**BANKS BUILDING
NEW CASTLE, DELAWARE**

**OCTOBER 10, 2011 INSPECTION
&
CONDITION REPORT**

**Prepared for the
Mayor and Council of New Castle, Delaware**

Richard O. Byrne
Architectural Conservator
Staunton, Virginia

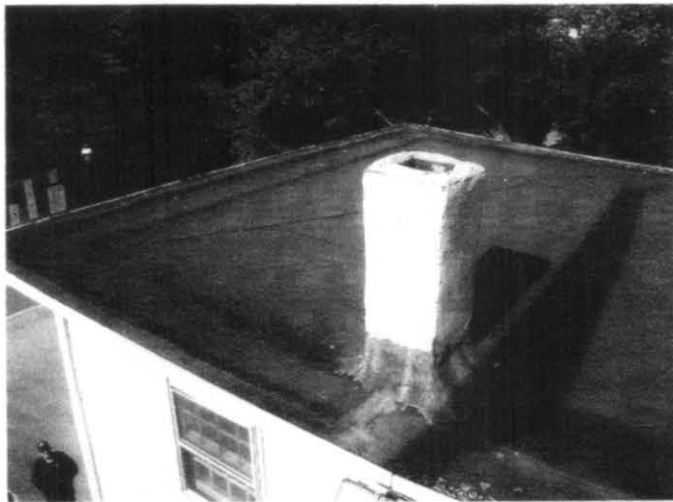
General view of the roof from the east side.

Using the city’s lift bucket we were able to get a clear picture of the roof’s condition. The roof is covered now with a built-up felt and tar fabric that is itself starting to crack open from expansion-contraction in the heat and cold...being a black roof one can imagine temperatures ranging from of -30°F to 150°F.

The diminutive chimney that once worked with an iron stove in the office has been smeared over

with a concrete stucco and its flashing (or what is left of it) lie buried beneath a layer of pasted on tar.

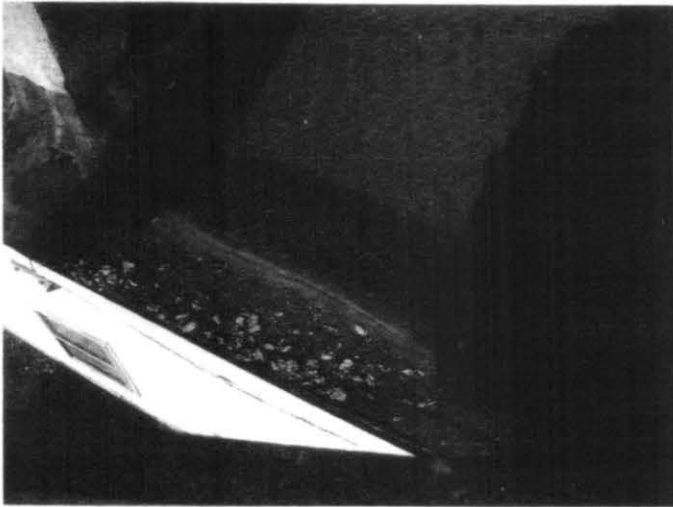
Debris in sagging gutters

The west and east sides of the building's box gutters have been covered over with tar and sag rather dramatically. The resultant swale on both sides is about 3-4" deep with old leaves and dirt. Making matters worse the downpipes have fallen away (stolen?) and water has all but destroyed the timber frame of the NE corner of the structure. It is a blessing that something is being considered about repairing the building as it can not suffer damage much longer.

1. Install temporary downpipes immediately even before other work begins. They are critical to holding back any more damage.
2. The skill of the attending carpenters must be at the highest level.

3. The existing crown moldings are badly distorted and sections of them may need being re-milled for replacement.
4. The box gutter needs being rebuilt. One can expect considerable rot in its two middle side areas.

5. Rather than lining the new box gutter with tin plate (terne is no longer used as it contained lead) the gutter can be designed and built with 60 mil thick EPDM (**ethylene propylene diene Monomer (M-class) rubber**) rubber roofing materials well lapped and brought up under the lead edge of a new standing seam roof. It should have a life expectancy of 25 years if cared for and then it can be taken up and replaced with relative ease...where as tin soldered seams are almost impossible to repair because of oxidation and rust.

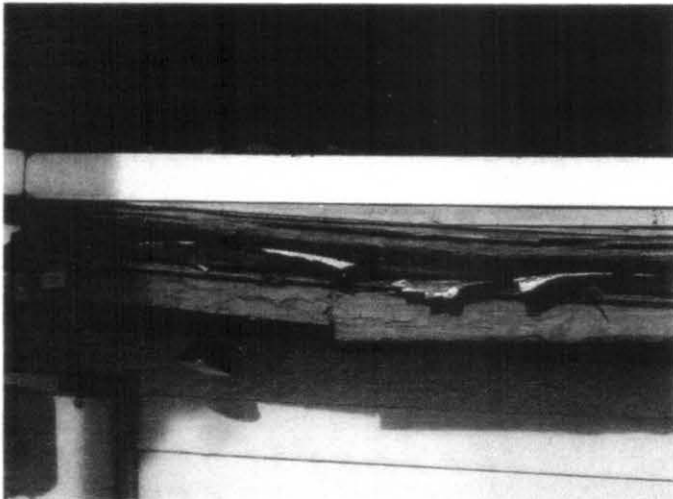
Rotted cornice and warped crown molding

Lowering over the edge of the roof one finds a cornice in near collapse. Its large crown moldings are still there albeit twisted and loose. One can expect opening these cornices to find structural failure and rot with extensive carpentry needed to rebuild them.

8. Budget permitting, the entire cornice needs to be carefully gone over and loose paint removed with the test being the use of a knife point to see if the cleaning and scraping are well done. This work will require lead training certification of anyone who does the work that disturbs 20 or more square feet of exterior lead surfaces. Failure to comply can result in staggering fines.
9. It may be simpler to remove and reinstall the cornice brackets for their paint work and repairs. Their very removal will require lead certification.

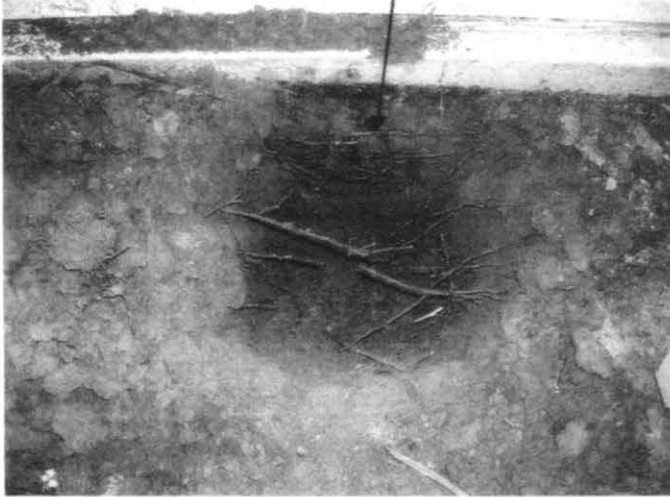
The creosoted 2x10” protective plank mostly saved the foundation

In order to build up the area around the house, fill was dumped right next to the building covering the original brick foundation. In an attempt to protect the sill and ends of wall studs and timbers a 2x10” pressure treated plank was nailed around the house at grade and below. The planking appears to have been bathed in creosote. The saving grace in this sad plot is the back fill is such that water drains away from rather rapidly. In order to bring good health to the

building, the building needs to be jacked up, the existing brick foundation repaired and extended up 18 to 24 inches to bring the building up out of the mud.

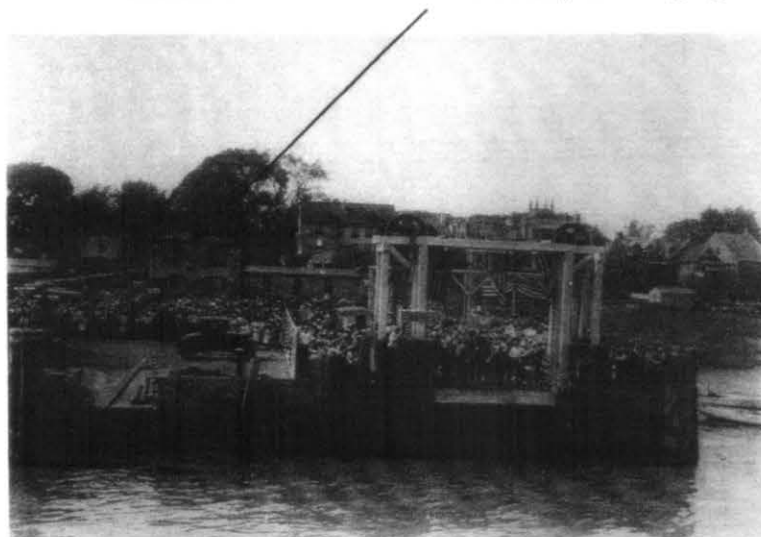
2/2 sash and shutters show at the new ferry landing opening

Before going inside one is struck by the eight-over-eight new sashes on the building. Simply put they were an attempt at gentrifying the building. The original sashes were two-over-two sashes and reflected industry’s technology at the time of being able to make and transport larger pieces of glass, thus the fashion for two-over-two sash. They

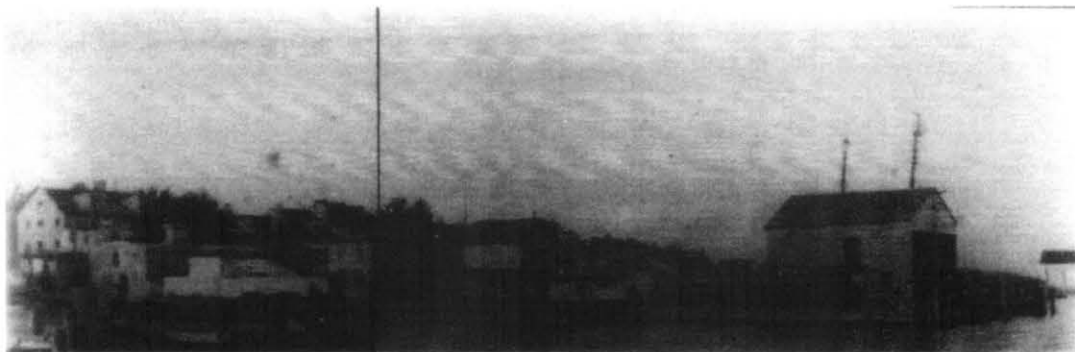
Note the east side entry door and dark shutters and Cornice

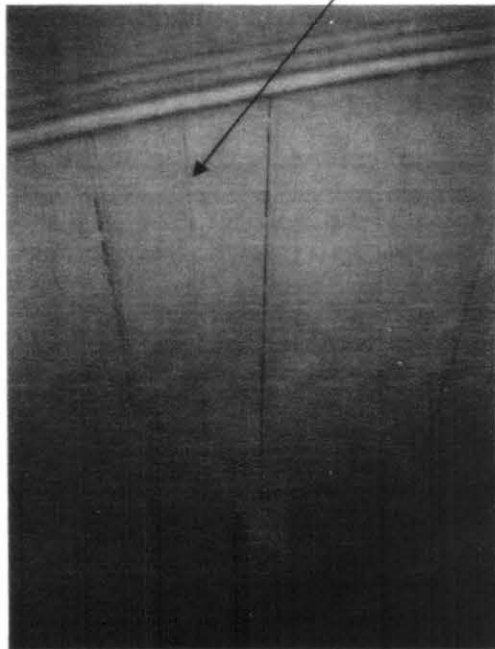
Wainscoting in staircase at knee wall height with quirk beading.

One should note that at the top of the staircase there is a wainscoted knee wall suggesting the top of the stairs was open to the entire first room of the second floor, which would suggest an office use. Once new floor rugs etc. are removed from the second floor the original wall placement outlines will reveal themselves along with probable openings where heat registers were, and if the chimney had an opening in it for a stove on the second floor.

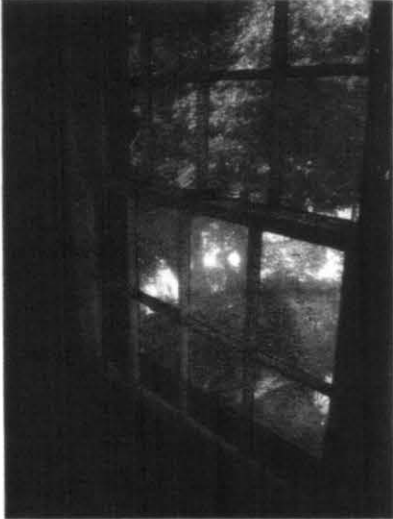
Of curious note these rather recent new gentrified sash show a common failure of today's window makers in that their glass panes were not "back puttied"...that is to say there was no putty put between the glass and wood muntins against which they sat. The result was, and still is, that condensation on the inside of the glass runs down into the muntin as there is no putty to seal it out. Once the wood is soaked, the paint comes off and the sashes start to rot, and with the rot the screws in the window locks become worthless and the windows are no longer secure (hence storm windows

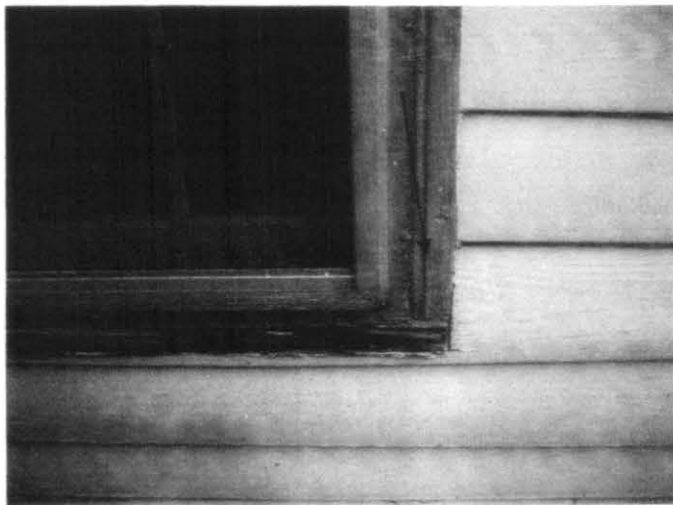
Showing a window sill in need of replacement.

Note the quirk beaded casing.

Currently the original window casings and jambs are for the most part still present and repairable. All of the exterior casings have quirk beaded molding profiles. Some windows have rotted sills. The window's blessing from the weather and lack of care has been their aluminum storms which need to be removed.

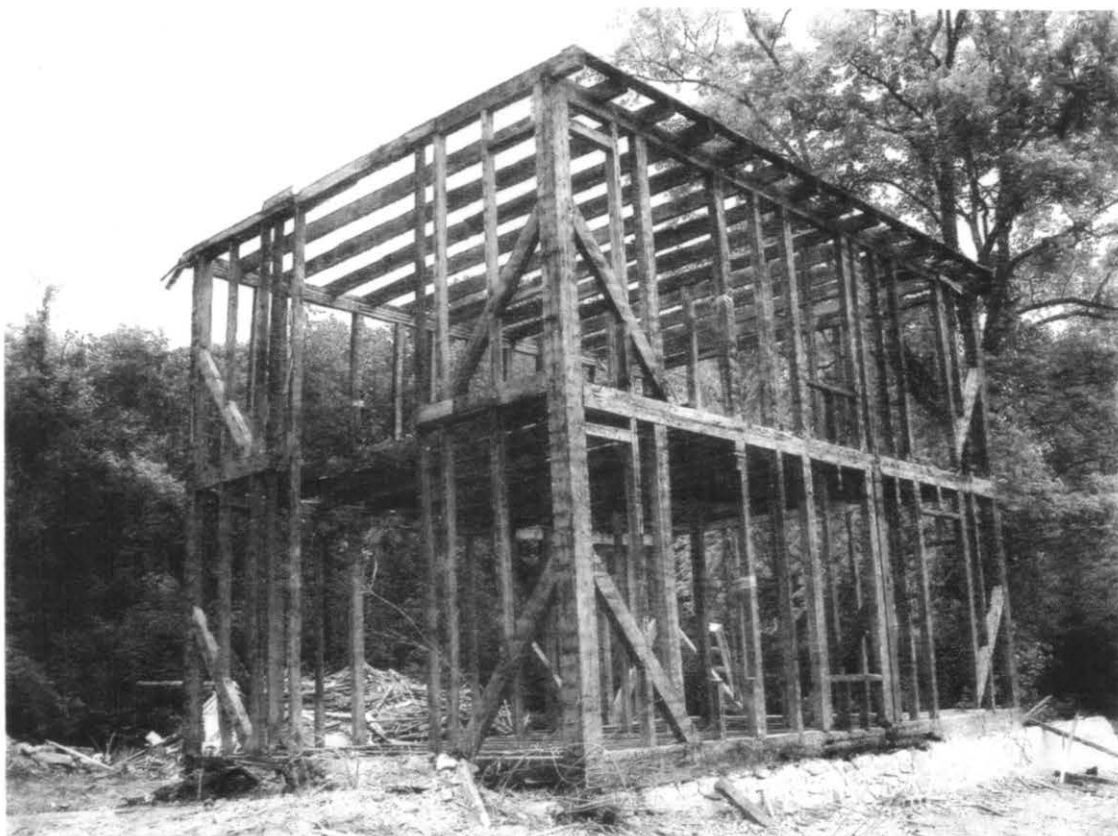
THIS TIMBER FRAME SKELETON RESEMBLES PRETTY MUCH HOW THE BANKS BUILDING'S FRAME APPEARED WHEN IT WAS BEING BUILT. BRACES WERE AT THE TOP OF THE POST NOT AT THE BOTTOM.
