SECTION 2. HISTORICAL CONTEXT.

SECTION 3. SURVEY METHODS AND RESULTS

The IMH research vessel *Roper*, a 36-foot converted shrimp boat, conducted a remote sensing search by sidescan sonar, from the one-fathom isobath to the edge of the shipping channel, and from below the flagpole in Battery Park to above the old ferry terminal at the foot of Chestnut Street (marked "Ruins" on Figure 3). Search lanes were spaced 80 yards, with the maximum sonar range also set to 80 yards to achieve 200% coverage of the area.

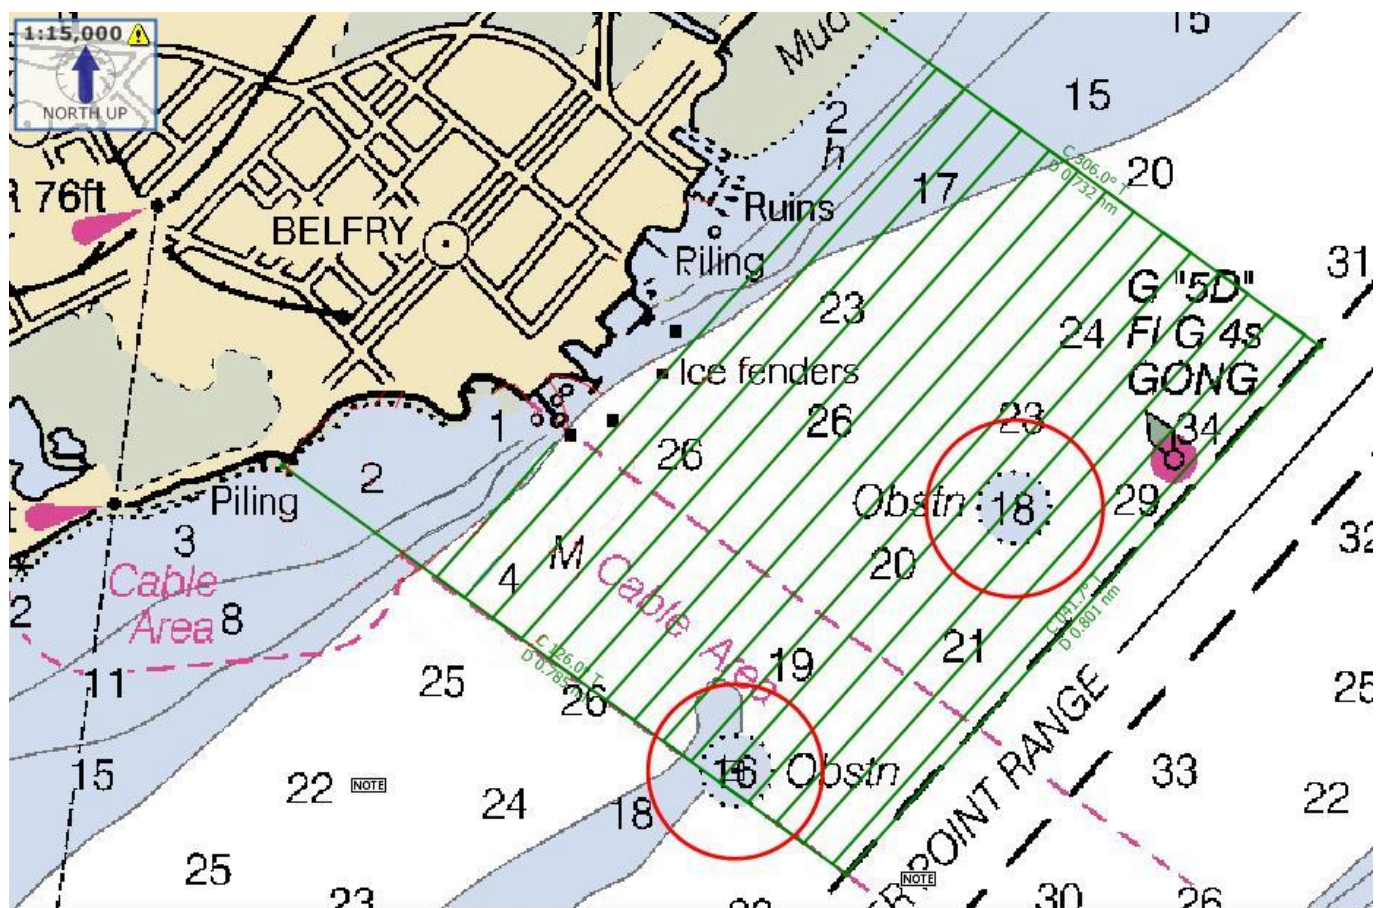
Figure 3. Navigational chart 12311, showing sonar survey tracks out to the navigational channel of the Delaware River.

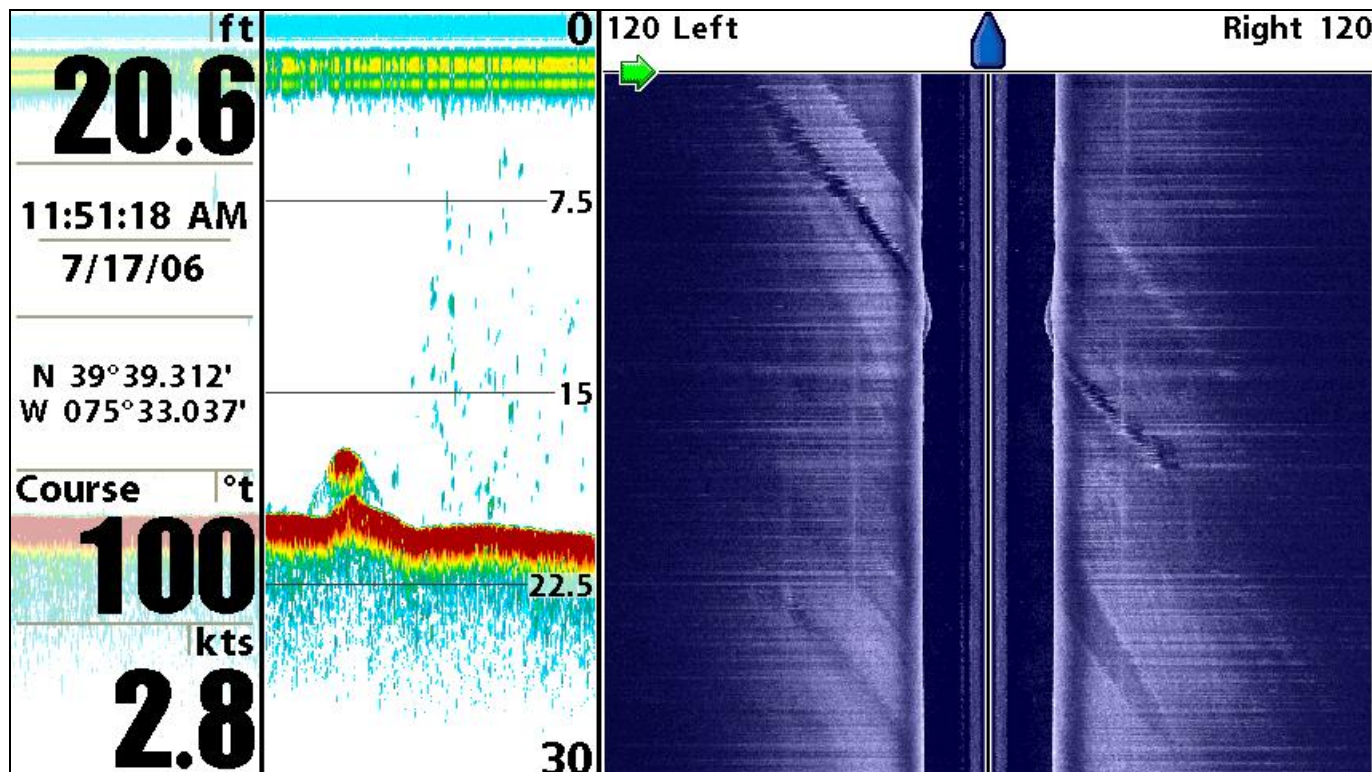
Figure 4. Data display from Humminbird 987C SI. Data and fishfinder image to left, sidescan image to right.

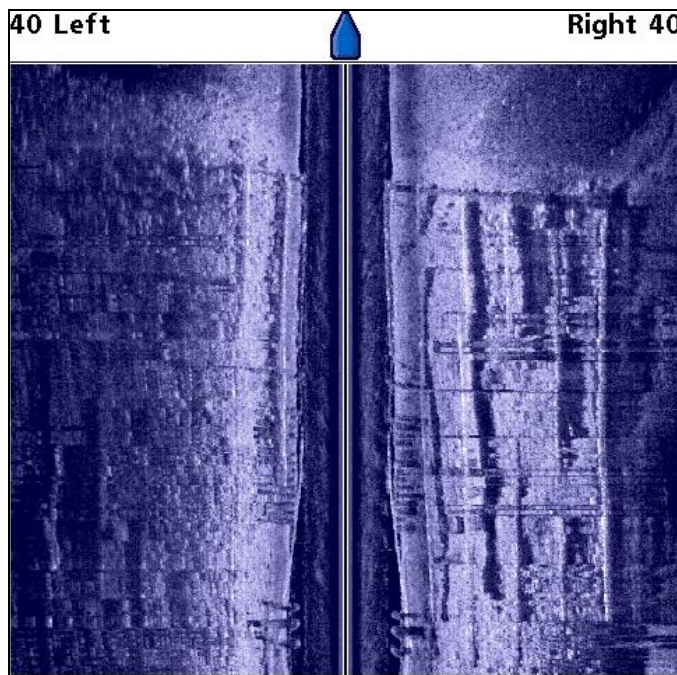
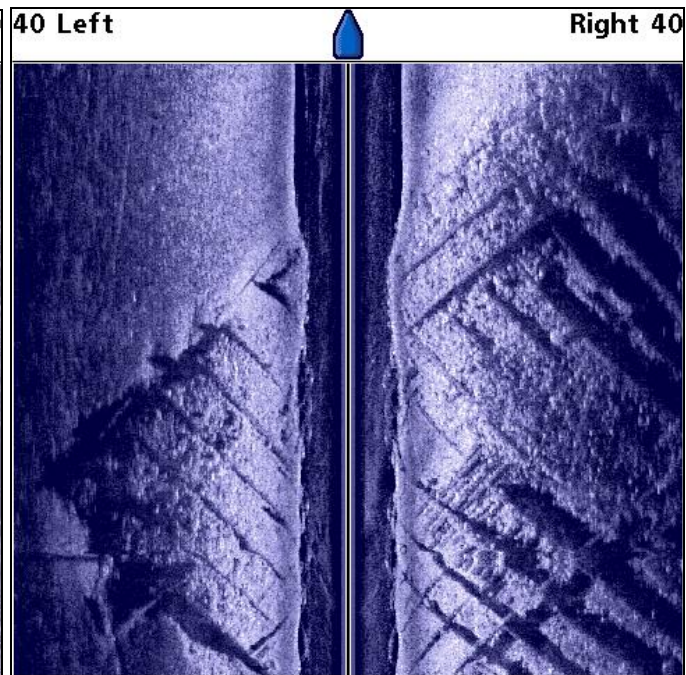
Targets 58 and 59, lying south of the courthouse cupola (marked "BELFRY" on Figure 3) and directly off Battery Park, were parts of a large wooden crib structure which was investigated by the shore team and is reported in part D(4) of this section. Figures 9 and 10 are sidescan sonar images of the structure, which measures approximately 75 by 120 feet. See Figures 38 through 47 and their accompanying text, pages 20 et seq., below.

Figure 9. Sidescan image of cribbing.

Figure 10. Sidescan image of cribbing

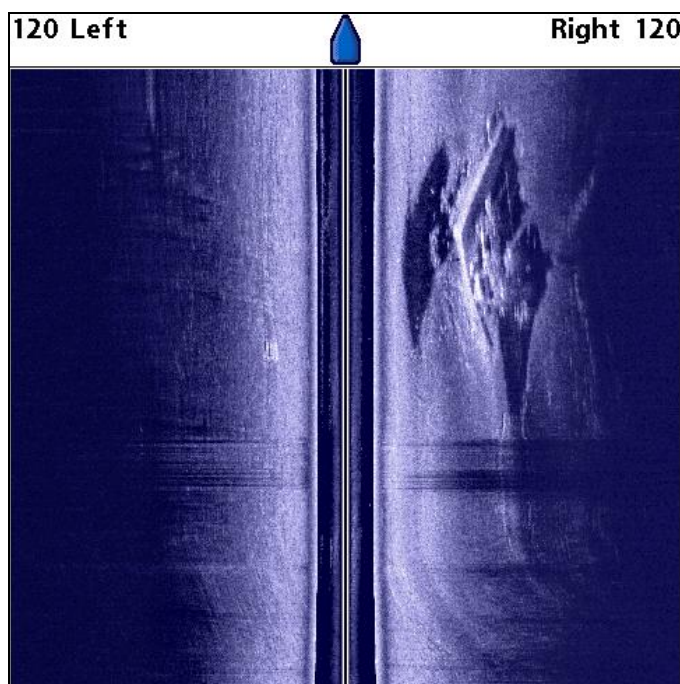
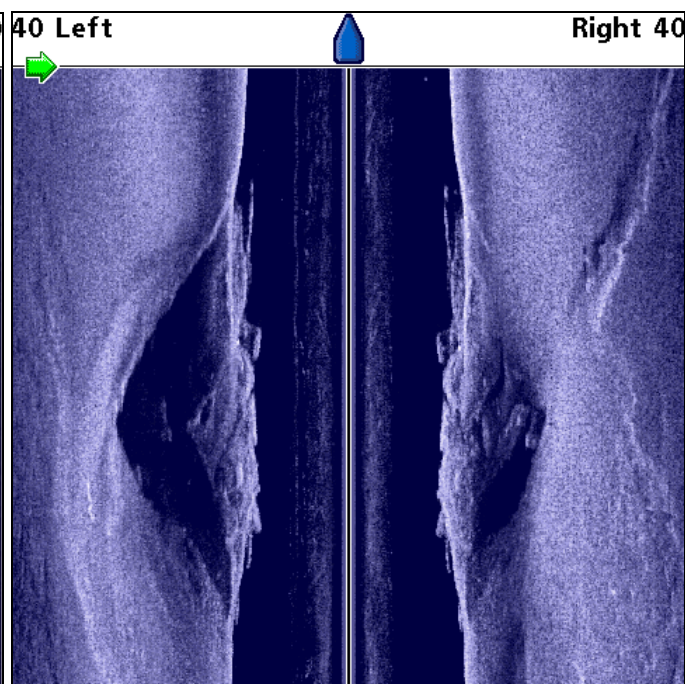
Due to shallow water we did not sidescan the old ferry terminal area (see map in Section 1). Approximately 250 yards southwest of the terminal we found a large, diamond-shaped, timber and stone structure, which is believed to be the remains of an ice pier that was destroyed by ice in January 1927. See Figures 11 and 12, below. Divers measured the sides to be 8.6 to 8.7 meters long. A least depth of 7 feet was found by sonar. Water turbidity prevented detailed analysis.

Figure 11. Submerged diamond-shaped ice pier.

Figure 12. Same in larger view, vessel passing over it.

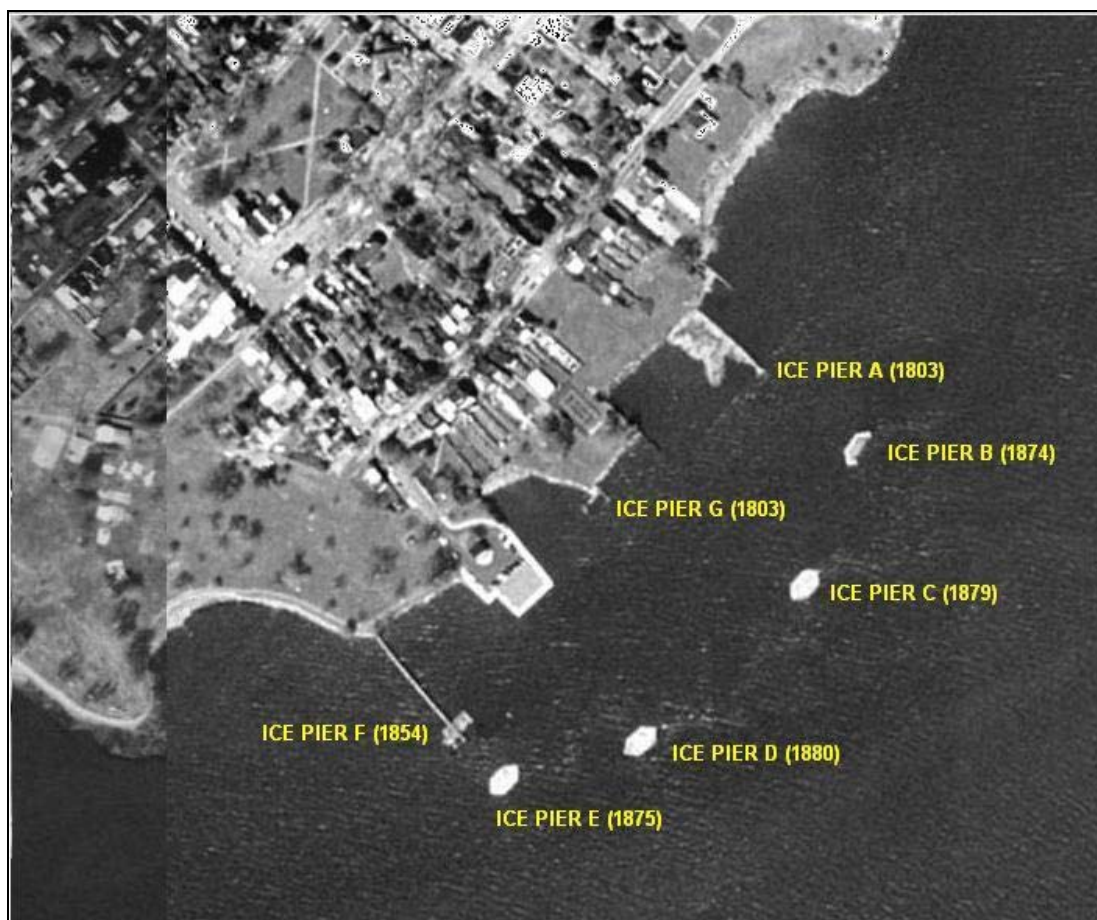
The sunken structure lies northeast of a line connecting the northeastern 1803 ice pier ("A" on Figure 13, or "B" on Figure 14) and the 1874 ice pier ("B" on Figure 13, "K" on Figure 14). Figure 14, a Corps of Engineers map dated 1879, shows a hexagonal or lozenge shaped ice pier ("H") lying right on that line, but the structure we found does not conform to that map either in position or in shape.

Figure 13. Aerial photograph of ice piers, with dates of construction and letter designations from National Register nomination.

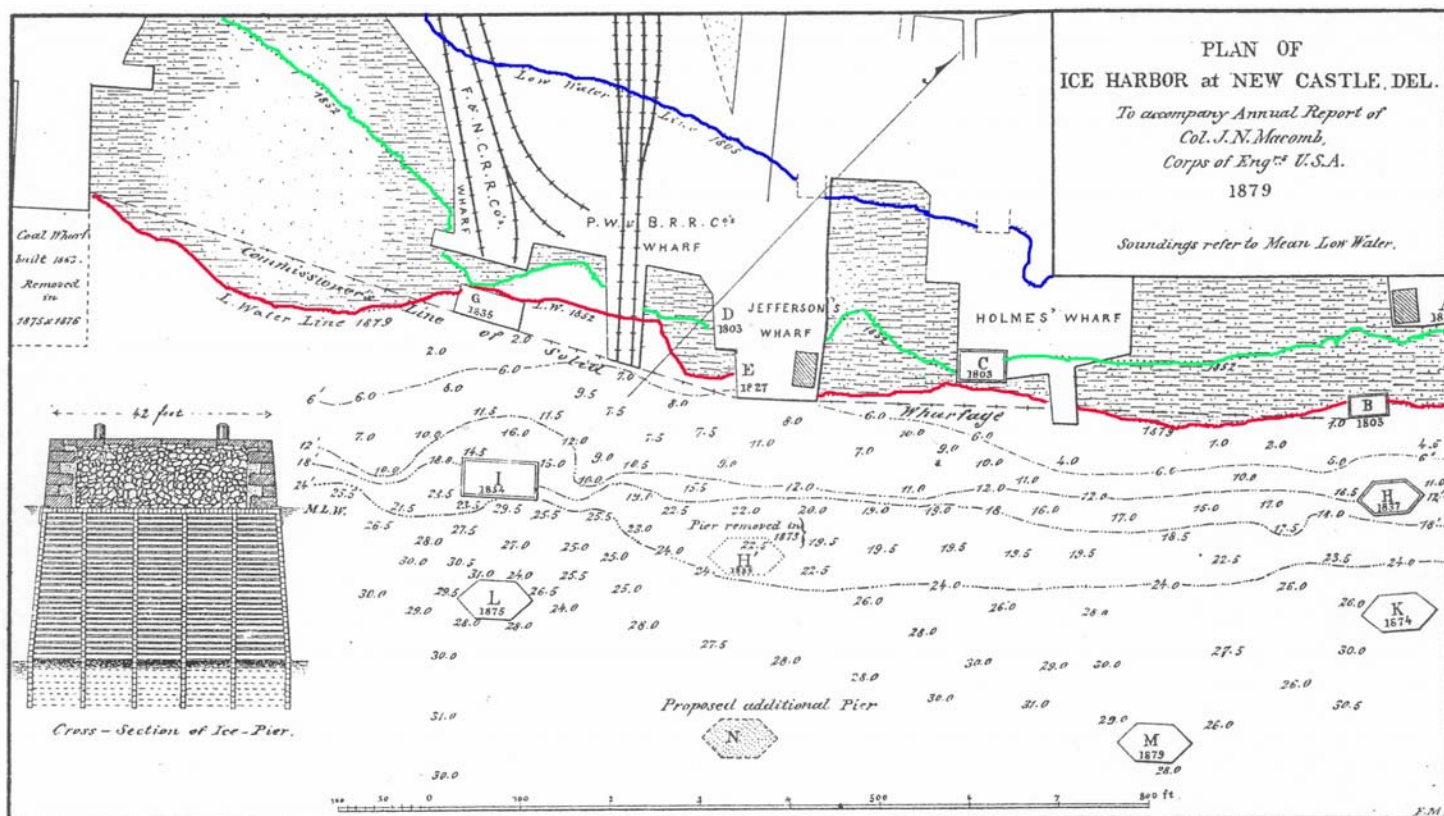
Figure 14. US Army Corps of Engineers diagram of the New Castle waterfront dated 1879.

Figure 14 indicates that another, hexagonal pier (marked "H") once lay directly off Jefferson Wharf but was removed in 1873. We did not find any scar or structure from that pier, but remnants might exist under the silt.

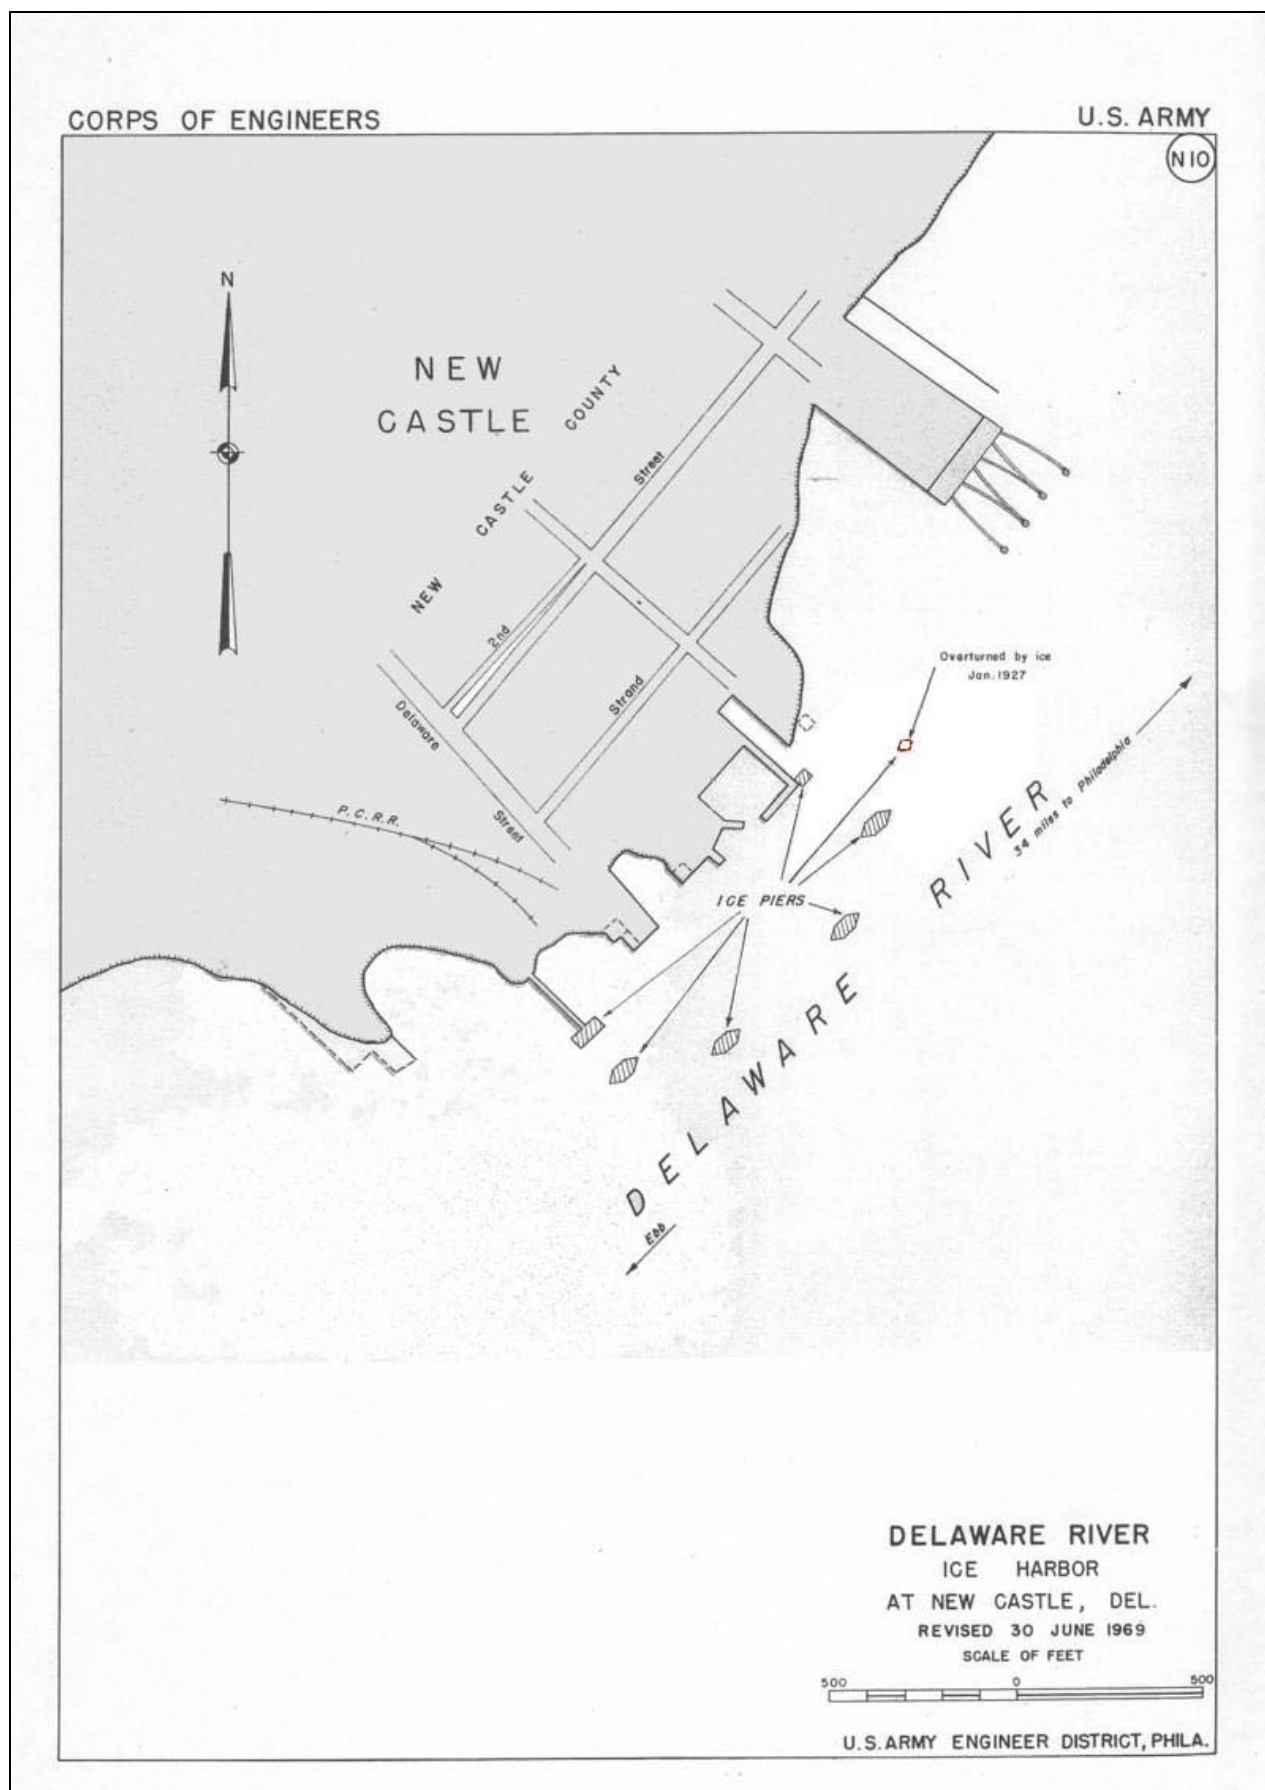
Another Corps of Engineers map dated 1969 (Figure 15 on next page) shows a diamond-shaped ice pier in that general area. The position we obtained by GPS does not quite agree with that map either, nor does that map depict the southeastern 1803 pier ("G" on Figure 13, or "C" on Figure 14).

Figure 15. U.S. Army Corps of Engineers plan for ice piers, 1969. A diamond-shaped pier was overturned in 1927.

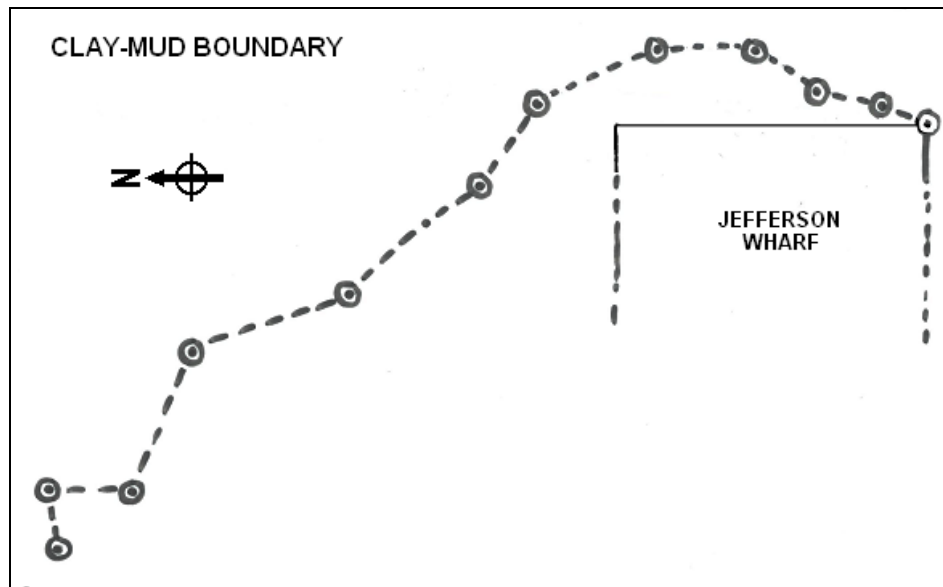
The boundary of the clay-mud transition along the river shoreline was plotted using GPS recordings by William Utley and Athena Trakadas. This boundary represents the line where the semi-solid bottom abruptly shifts to deep, unstable mud whose depth exceeds our longest probe (around 8 feet). These data were mapped on a Mylar overlay of the New Castle Harbor waterfront. See Figure 16 for those results.

Figure 16. Plot of clay-mud transition boundary

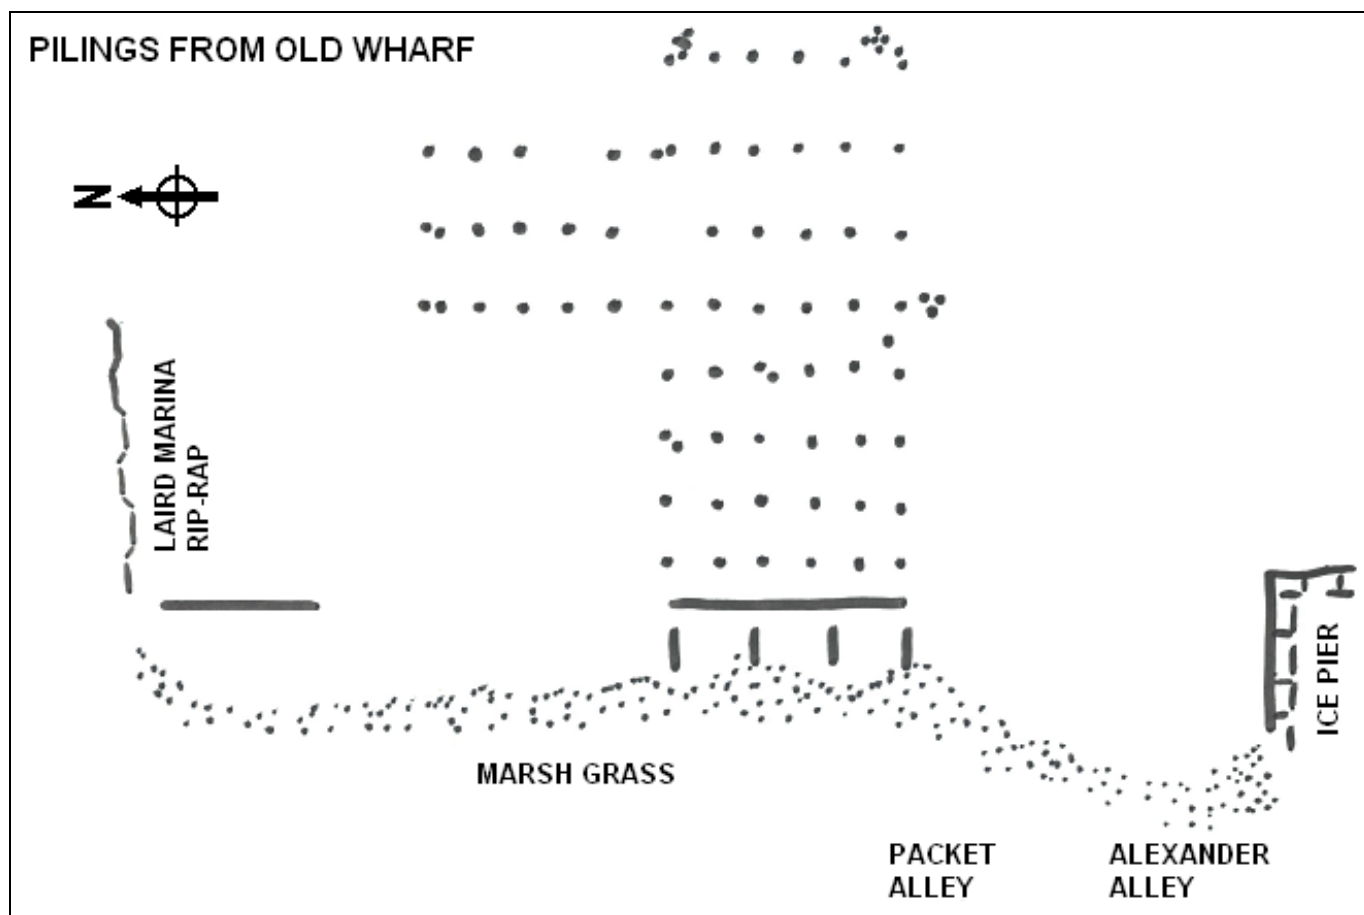
In the Packet Alley landing area an extensive array of wharf pilings extending into the river was examined by the shore team. Direct measurements were made on the overall dimensions of the pilings and on several of the inter-piling distances. The association of the L-shaped wharf pilings with shore support timbers and wooden buttressing at the shoreline was also documented in photographs. These details were most evident at low tide. A map of the assembly of wharf pilings is shown in Figure 32.

The wharf consisted of a major broad portion oriented directly out into the river, with a lateral narrower and shorter extension from the outer northern face of the complex. The corner pilings throughout the entire structure were reinforced in triplicate, but all other internal and intermediate pilings were individually placed. The spacing between the pilings averaged approximately 3.0 meters. The large rough timbers lying parallel to the end of the pilings were stacked on top of one another and anchored by long metal spikes. The heads of the spikes resembled truncated pyramids in shape. Several isolated spikes were pointed at their opposite ends.

Figure 32. Diagram to scale showing vertical wharf pilings in Packet Alley area.

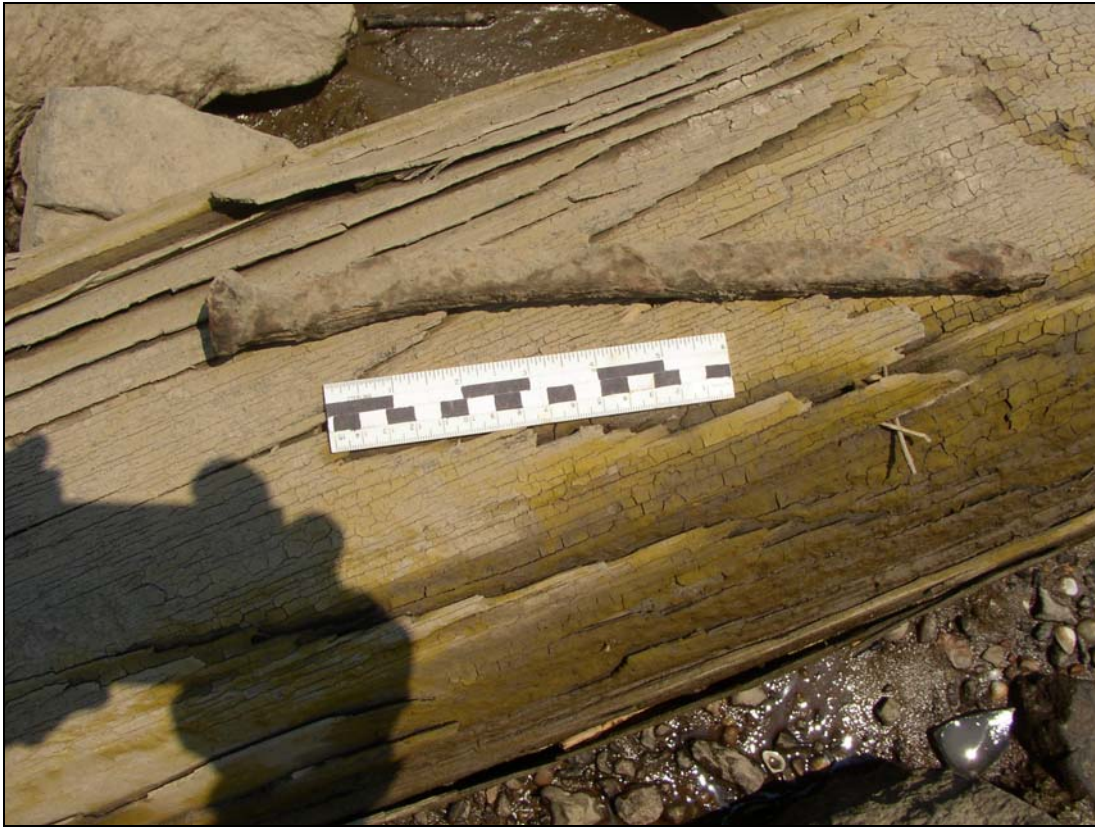
Figure 33. A foot-long spike dislodged from the horizontal timbers along the shore side of the pilings. The head of this spike is pyramidal, as seen in Figure 34.

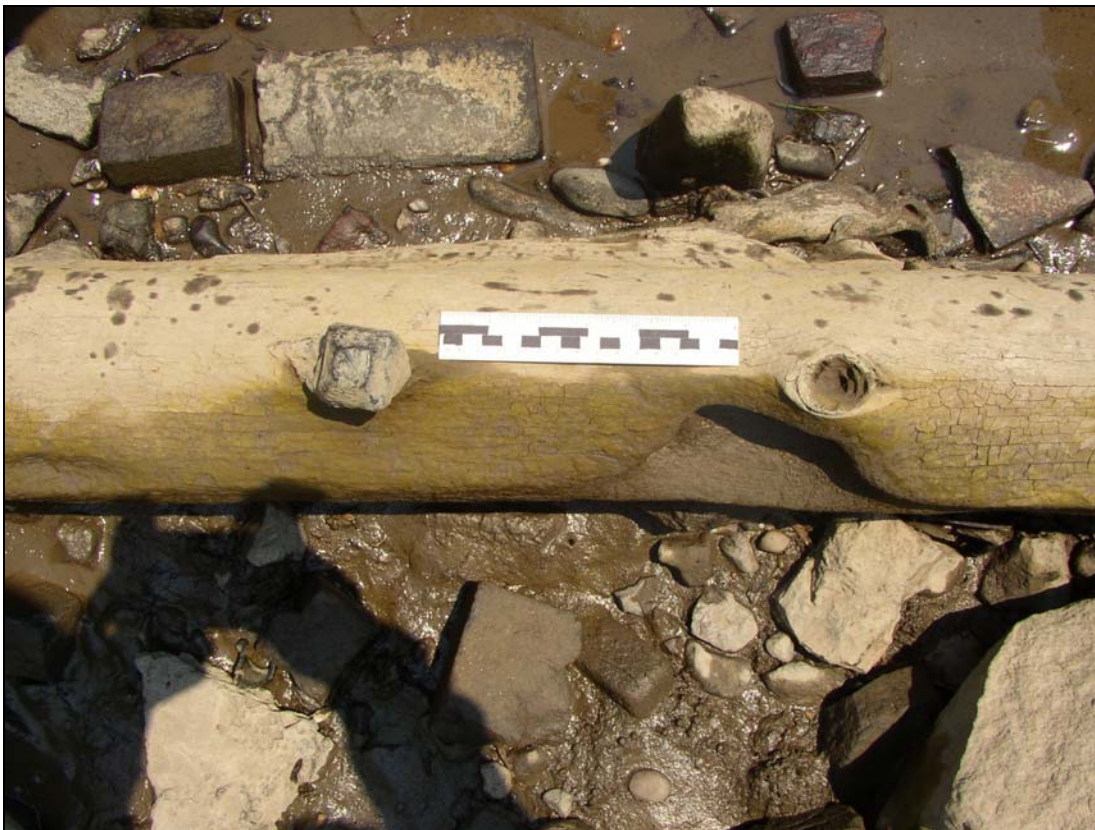
Figure 34. A horizontal timber with a spike in place from the Packet Alley site. Two red bricks lie in the sediment above the timber. The larger one is modern; the smaller one may be older and be a decorative brick used in a Flemish design pattern.

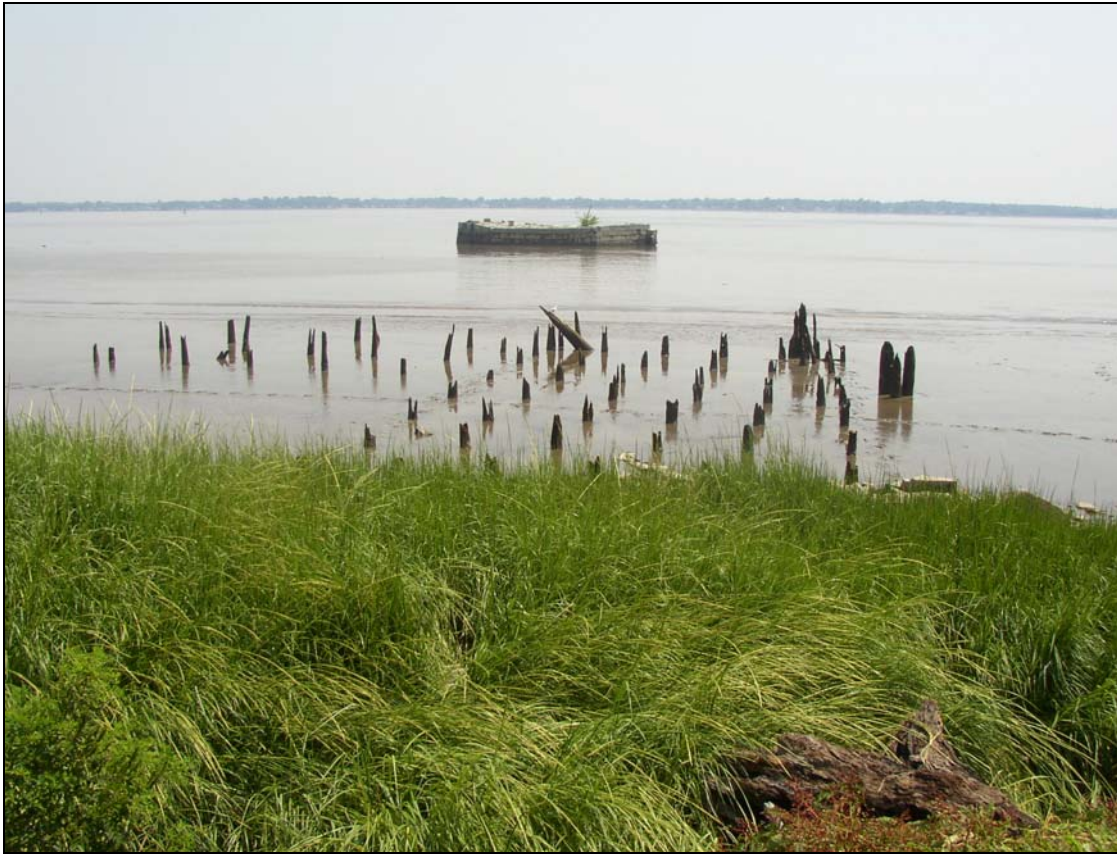
Figure 35. Exposed pilings in an L-shaped arrangement at the Packet Alley site. Ice pier "C" is visible in the background.

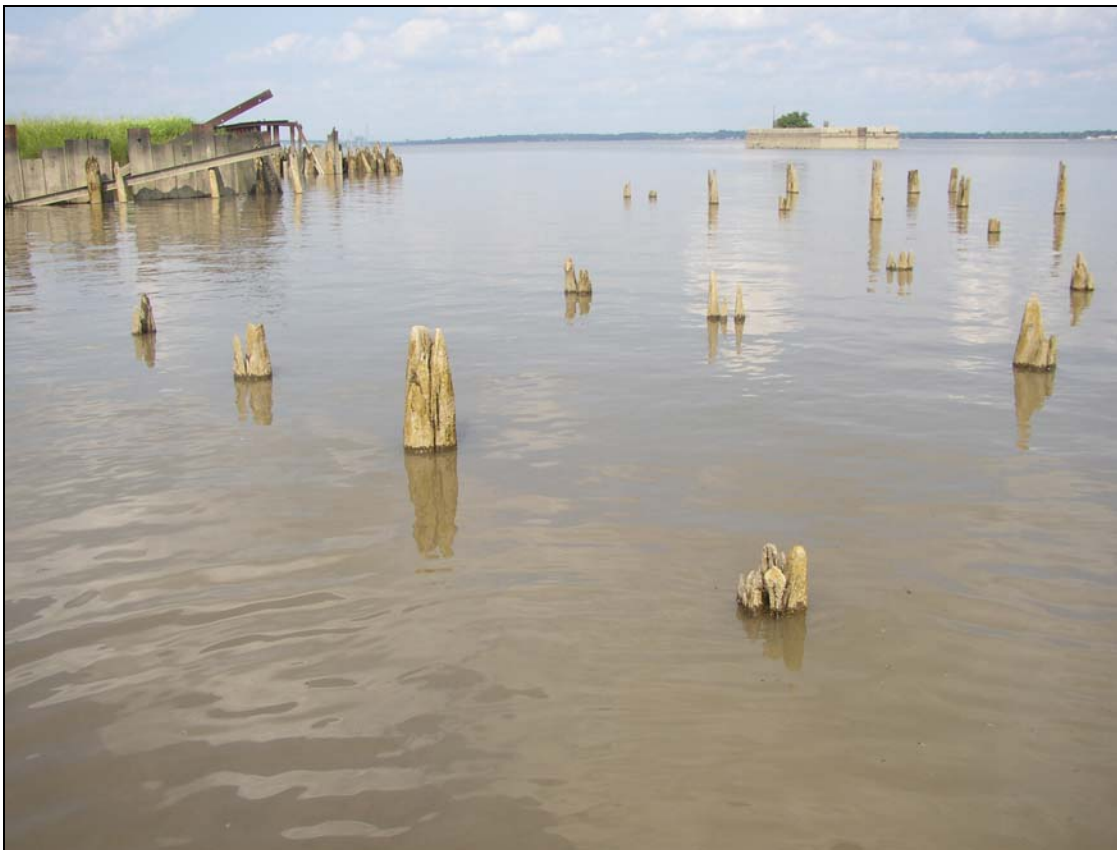
Figure 36. Looking upriver to the north to show the relationship between the pilings and remnants of the Laird marina to the left of the field. Ice pier "B" is seen in background.

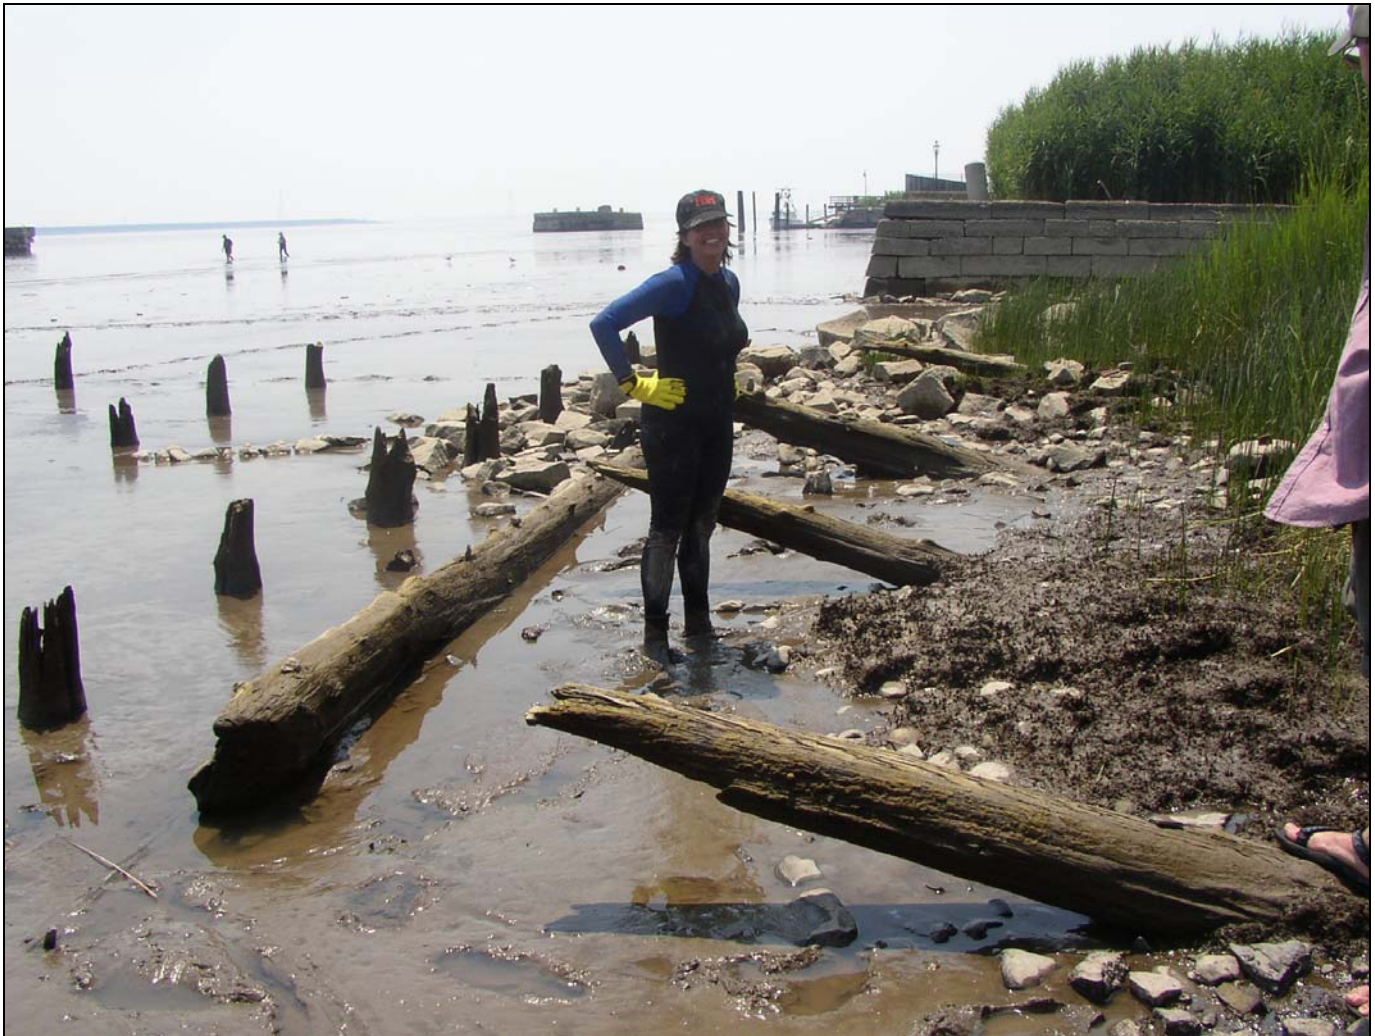
A set of deeply set, large, rough timbers of comparable thickness to the parallel shore timbers were angled at $\sim 30^\circ$ toward the pilings of the main wharf (Figure 37). Whether this set of timbers supported an inclined ramp from shore, or represented a shallow water reinforcement of the wharf proper, is not known.

Figure 37. The shore timber assembly looking downriver to the south. The inner ice pier "G" at the end of Alexander Alley is seen to the upper right of the field. Note the horizontal and diagonal wharf timbers.

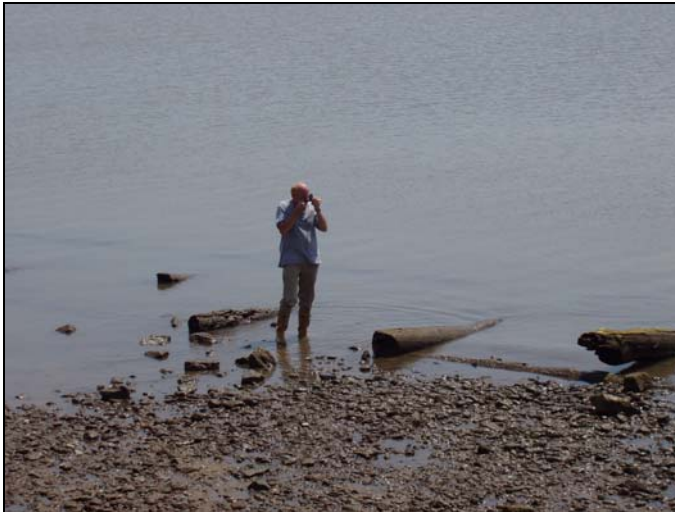
The cribbing consists of sets of timbers laid alternately parallel and perpendicular to shore on 5-foot centers. In some cases the timbers are notched into each other; in other cases they are simply laid and spiked. The interstices are filled with stone rubble.

Figure 38. Edge of wooden cribbing and gravel surface.

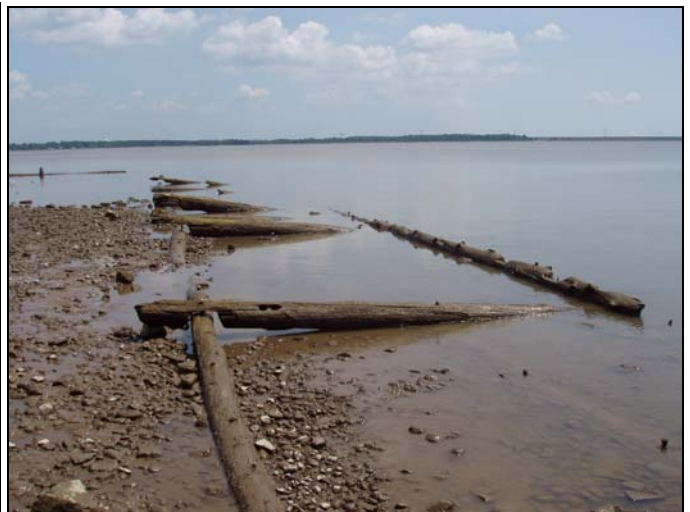
Figure 39. Another view of wooden cribbing

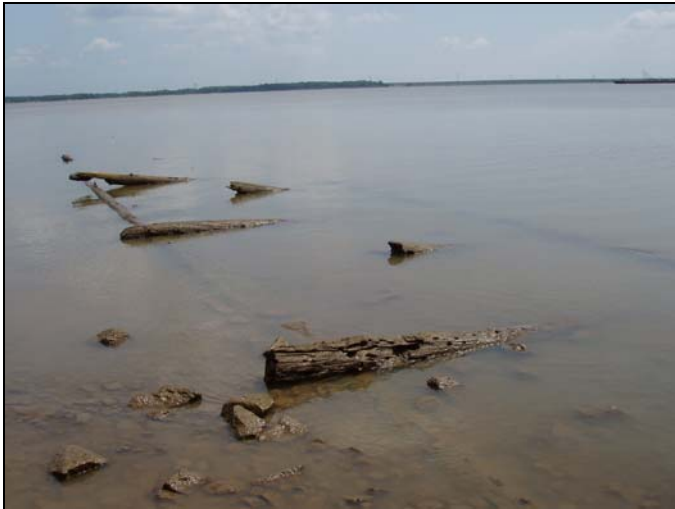
Figure 40. As tide comes in, the cribbing is submerged.

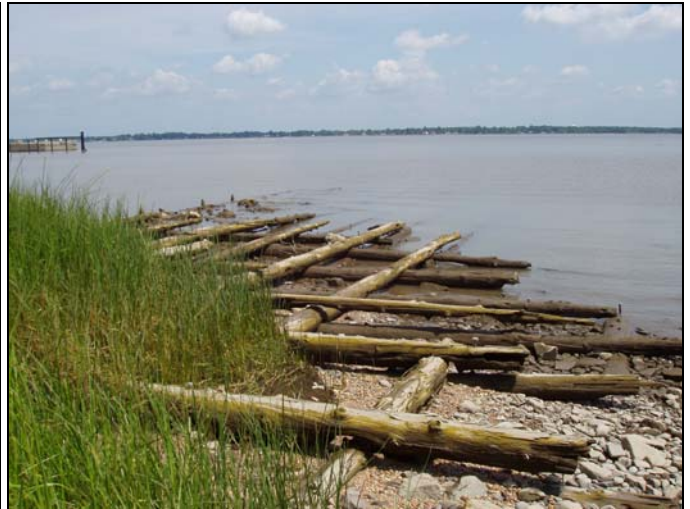
Figure 41. Cribbing viewed to the north. Ice pier F to left.

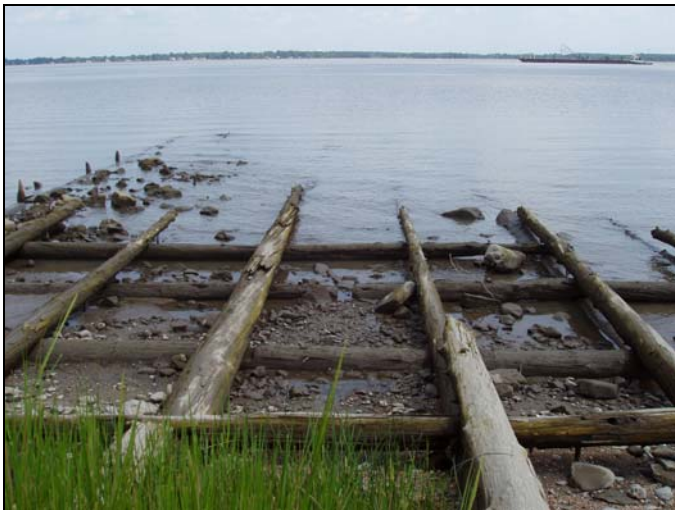
Figure 42. Cribbing further exposed.

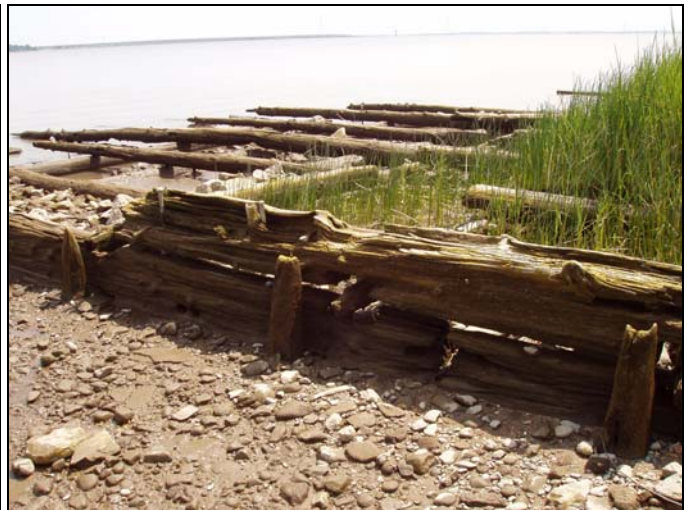
Figure 43. Shore cribbing

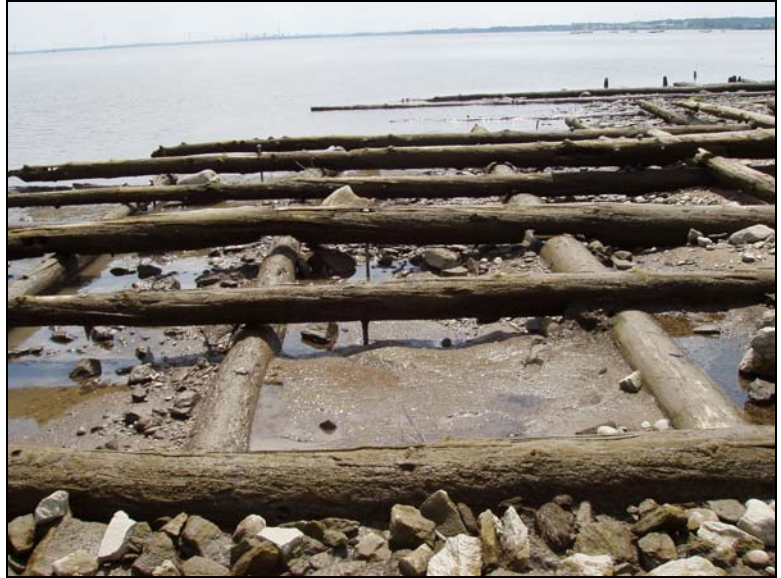
Figure 45. Detail of stacked timbers in cribbing

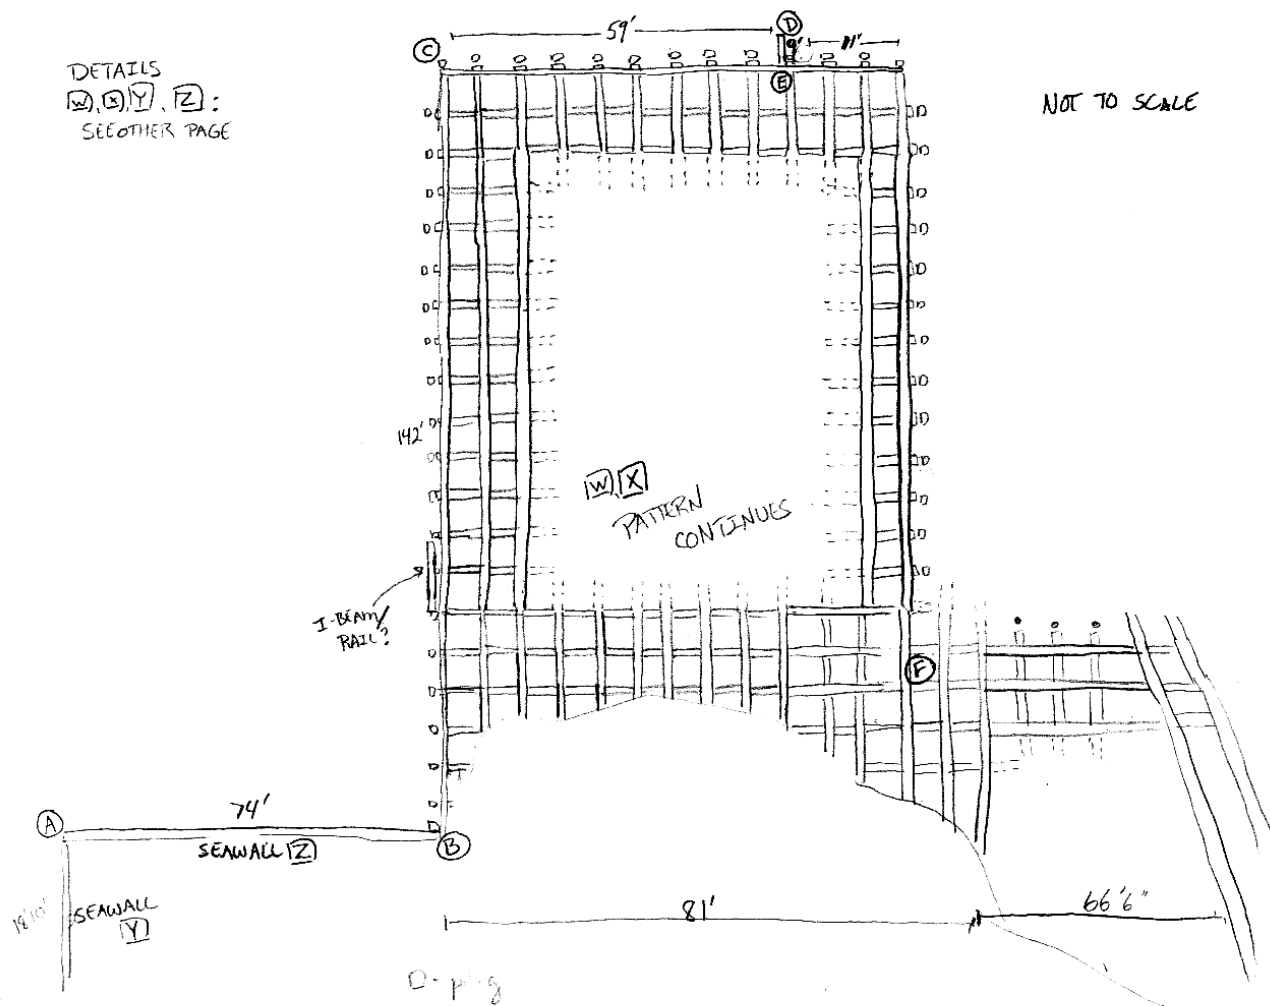
Off the point that extends into the river from the southern end of Battery Park, near the flagpole, is an extensive cribbing that was mapped by two members of the shore team. Several SCUBA dives were made on this site after it was discovered on sidescan by the boat team. Initial measurements were made underwater to determine the spacings of timbers and the subjacent metal cribbing of this assemblage. Photographs of portions exposed at low tide follow as Figures 38 to 45. Sketches by Michelle Damian and Athena Trakadas follow as Figures 46 and 47.

Figure 46. Overview sketch of Battery Park wooden cribbing arrangement.

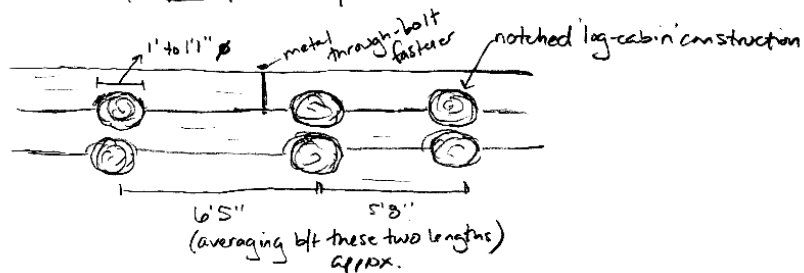
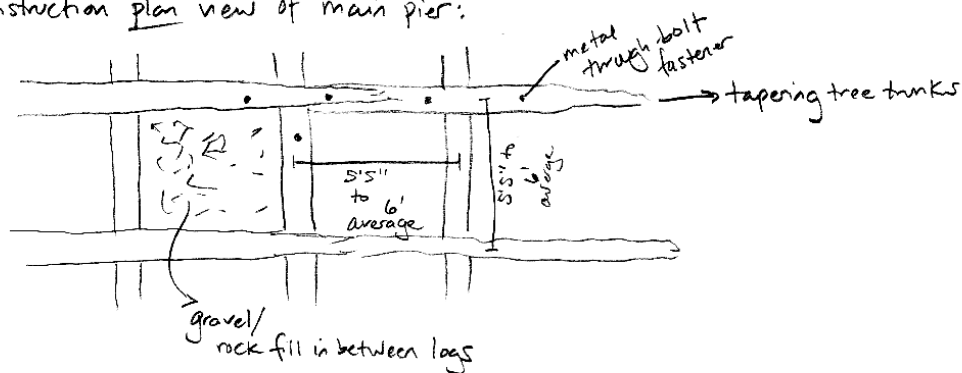
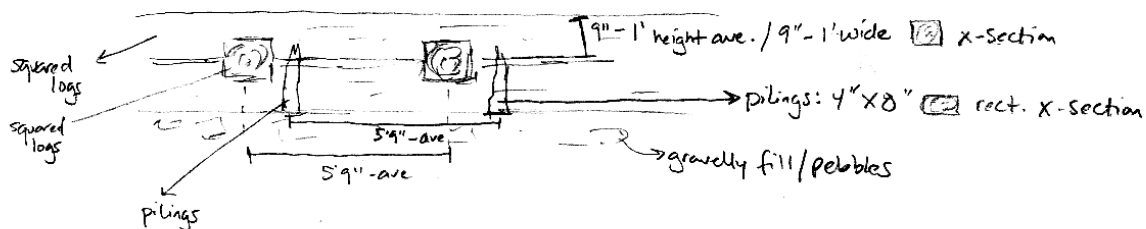
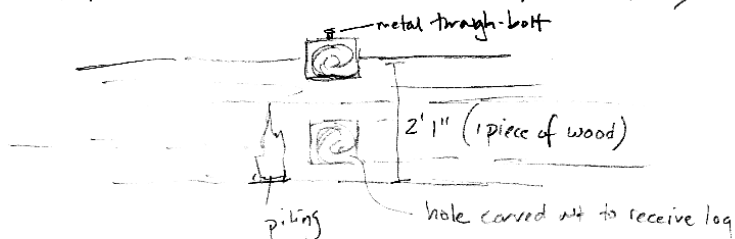
Construction profile of main pier:

Construction plan view of main pier:

Construction profile of shore seawall: (North face of main pier)

Construction profile of shore seawall: (East end of main pier)

Figure 47. Rough sketches of construction detail in the wooden cribbing along Battery Park waterfront.

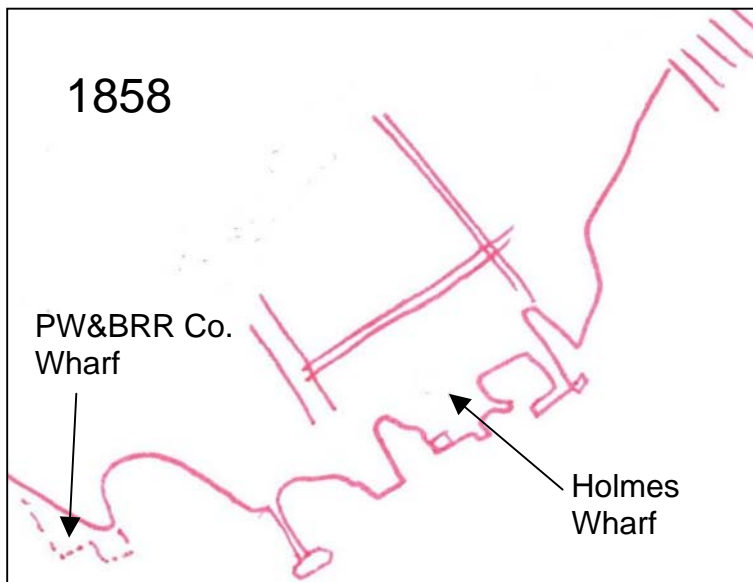
We identified vertical pilings from a wharf construction in the extended Packet Alley region of the shore. We also identified an area of extensive wooden cribbing off Battery Park. Reference to an 1858 map (Figure 48) reprinted in the New Castle Historical Society's summary of New Castle (Cooper, 2001) suggests an identity for both of these structures. As shown in the following outline from that map, the former might be remnants of the Holmes Wharf and the latter might be the PW&B Railroad Company wharf.

Figure 48. An outline of a map of the New Castle harbor dated 1858 showing a wharf owned and operated by the PW&B Railroad Company that corresponds in position to the Battery Park cribbing, and another wharf, the Holmes Wharf, corresponding in position to the pilings found at the extension of Packet Alley. From Cooper (2001), p. 115.
