NATIONAL REGISTER OF HISTORIC PLACES INVENTORY -- NOMINATION FORM

HISTORIC IRA LUNT HOUSE COMPLEX

This practice nomination document was prepared by Stuart Paul Dixon (1956-2008) in 1983 as a student at the University of Delaware. Courtesy Center for Historic Architecture and Design.

Ira Lunt House Complex
Proof Sheets

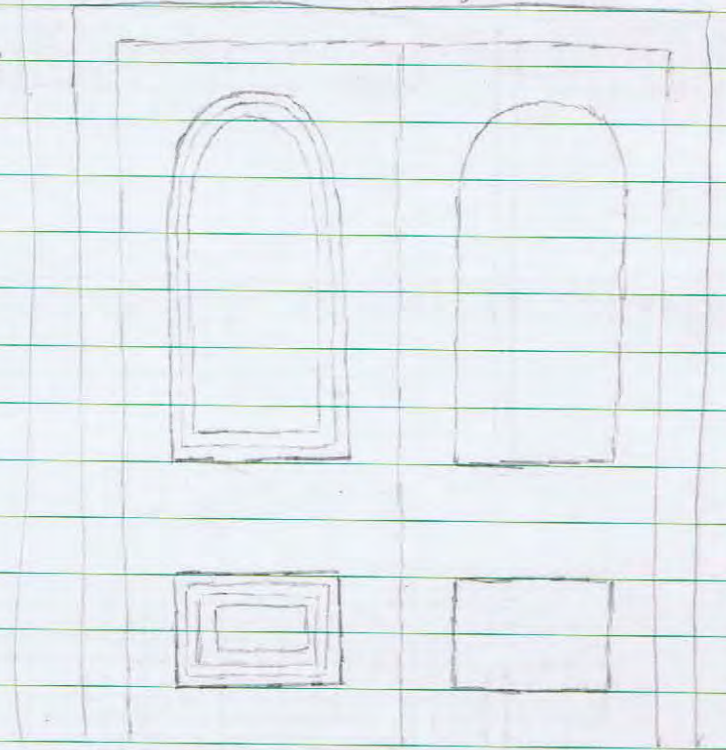
glass not orig. etched fronted
side of door frame & under frame
changes

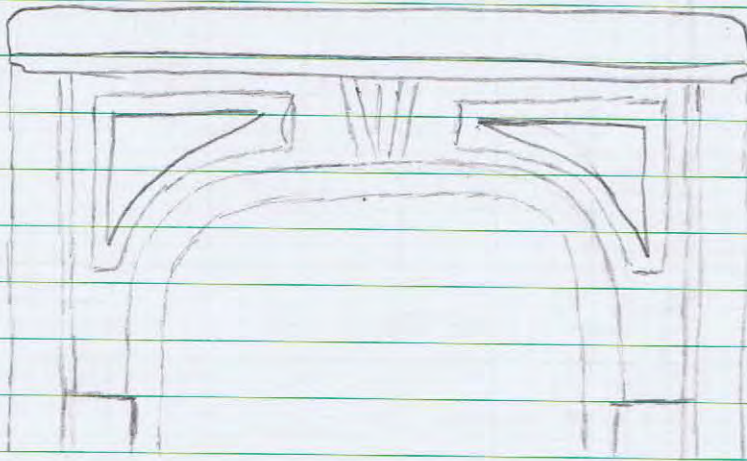
blue hole above fireplace, painted slate

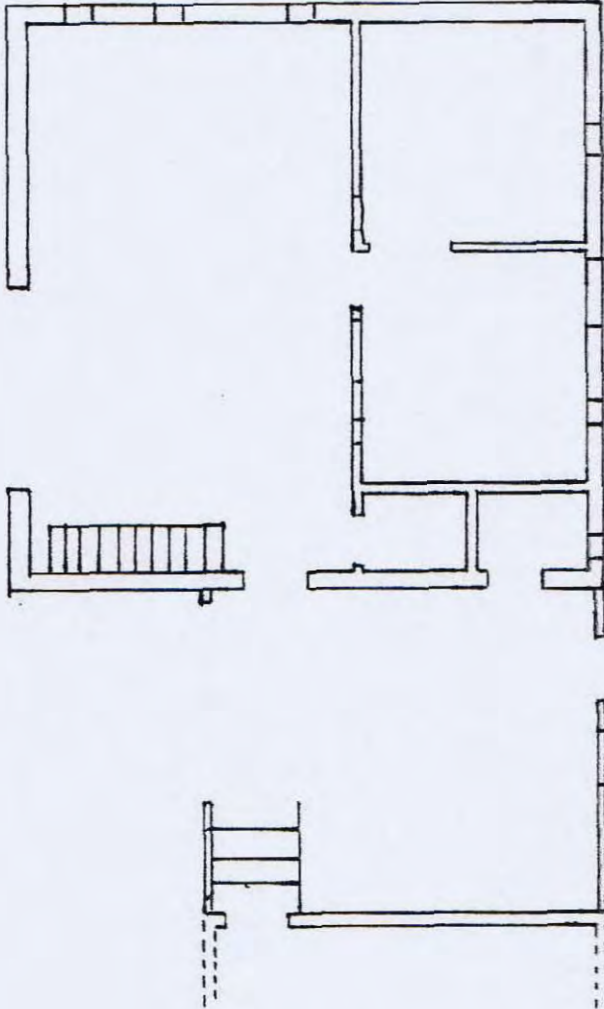
Ira Lunt House Complex
First Story Floor plan; Carriage House and Barn

WING

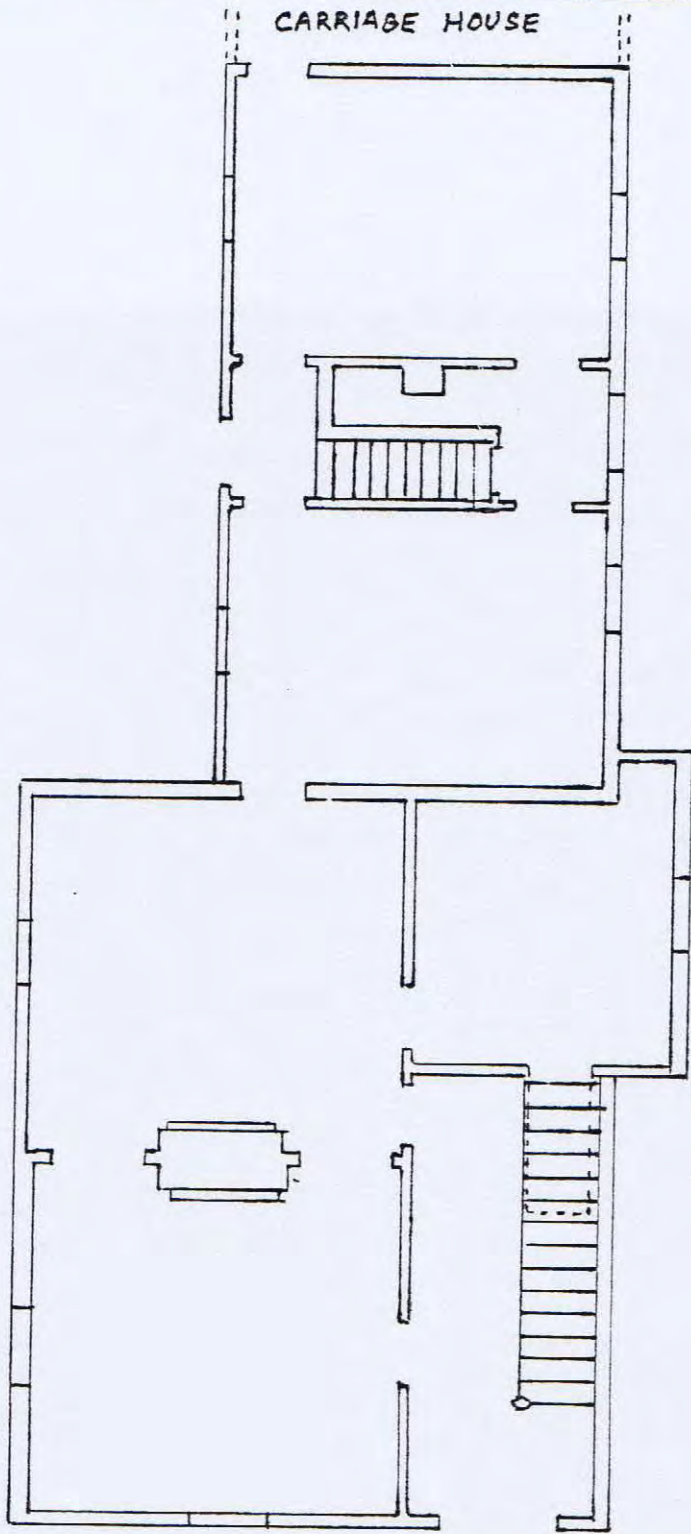
Ira Lunt House Complex
First Story Floor plan; House and Wing

1" = 8'

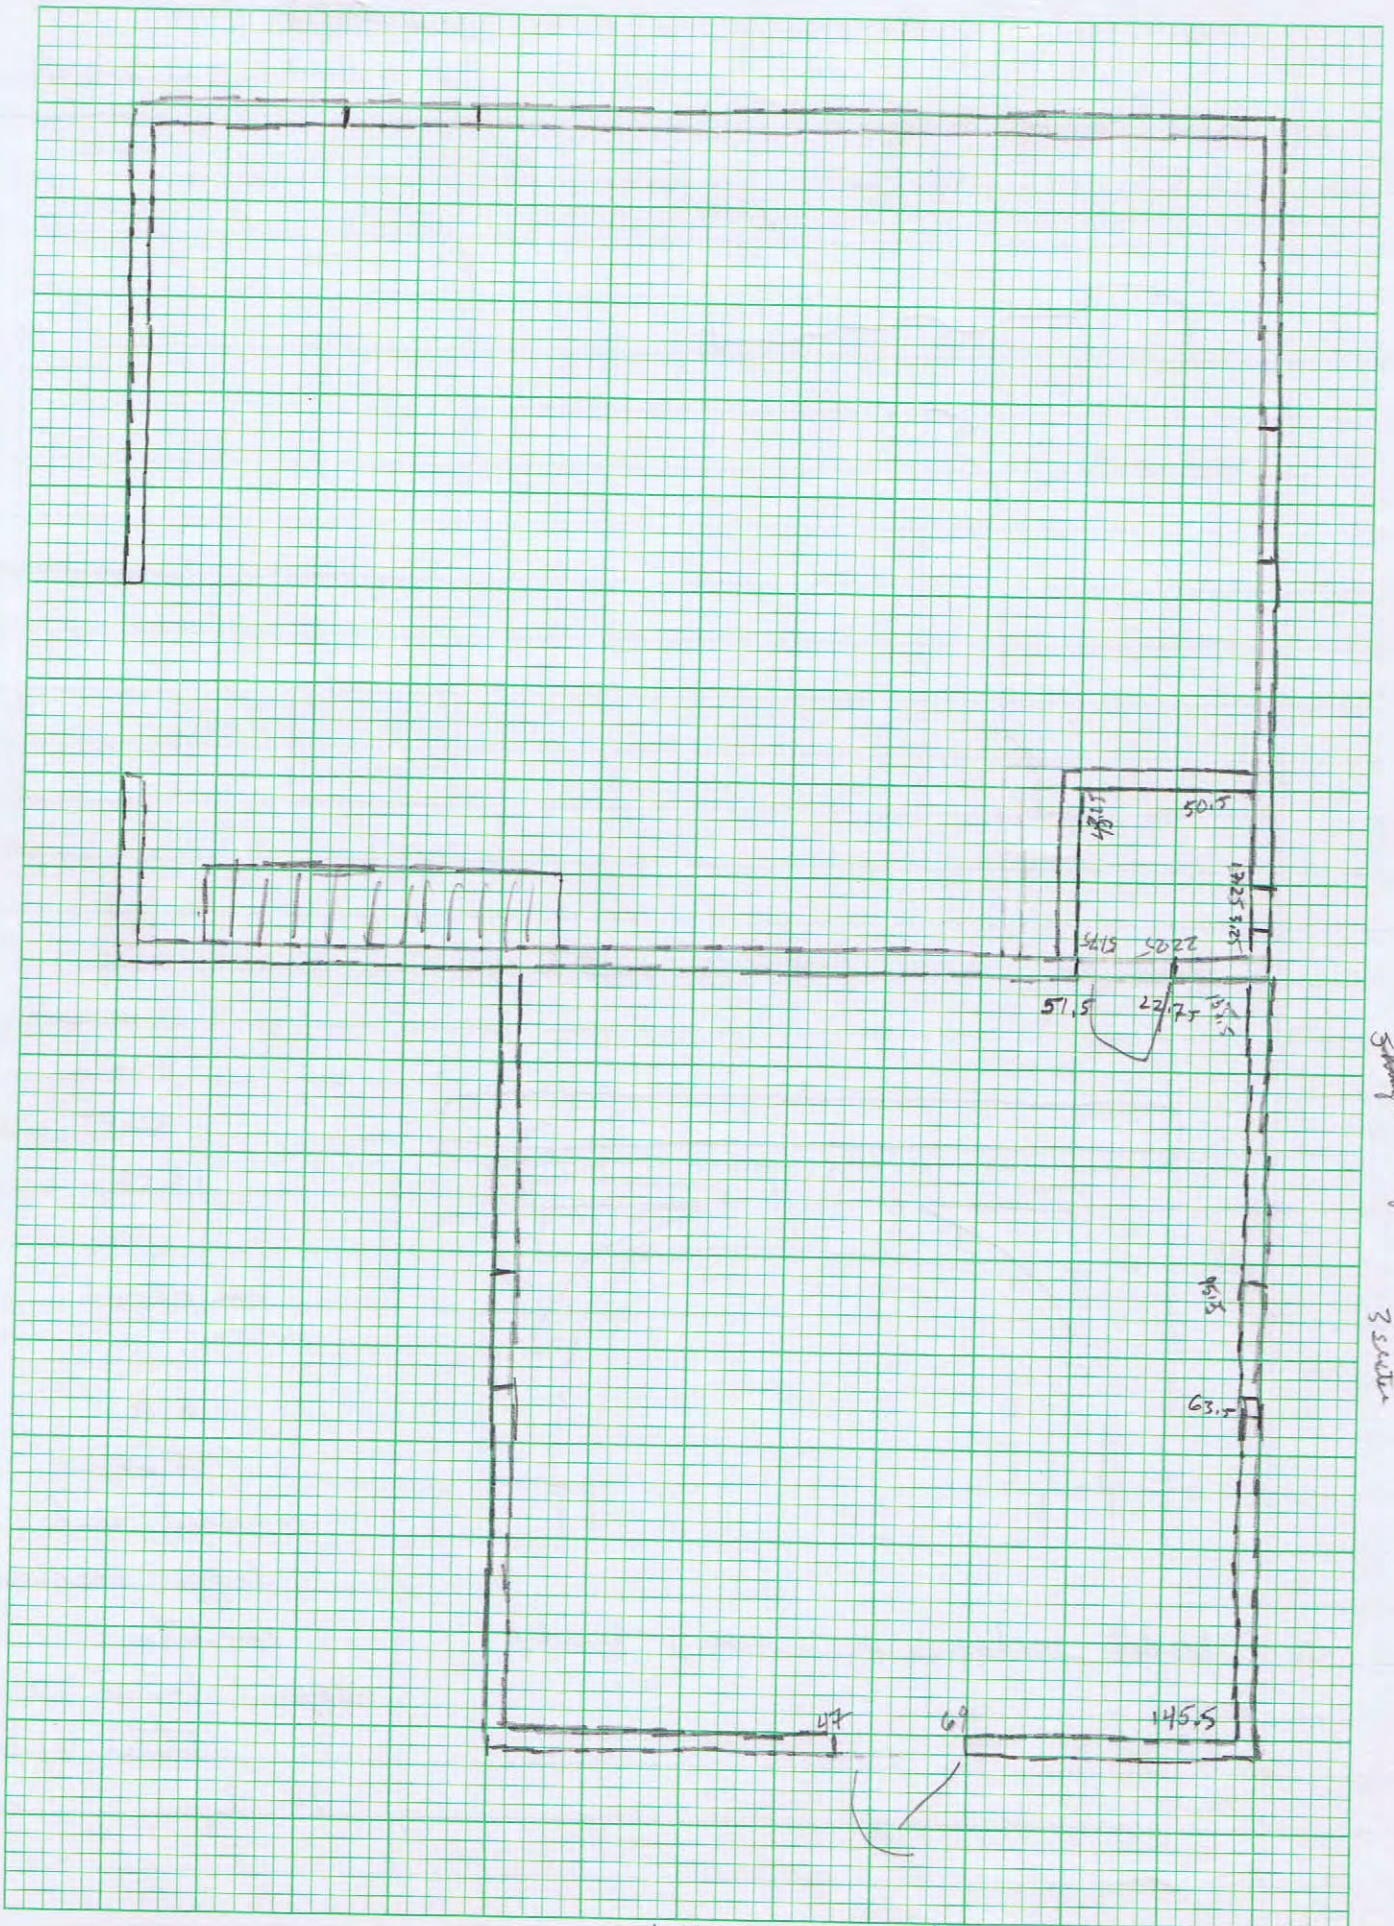
WING 2ND FLOOR

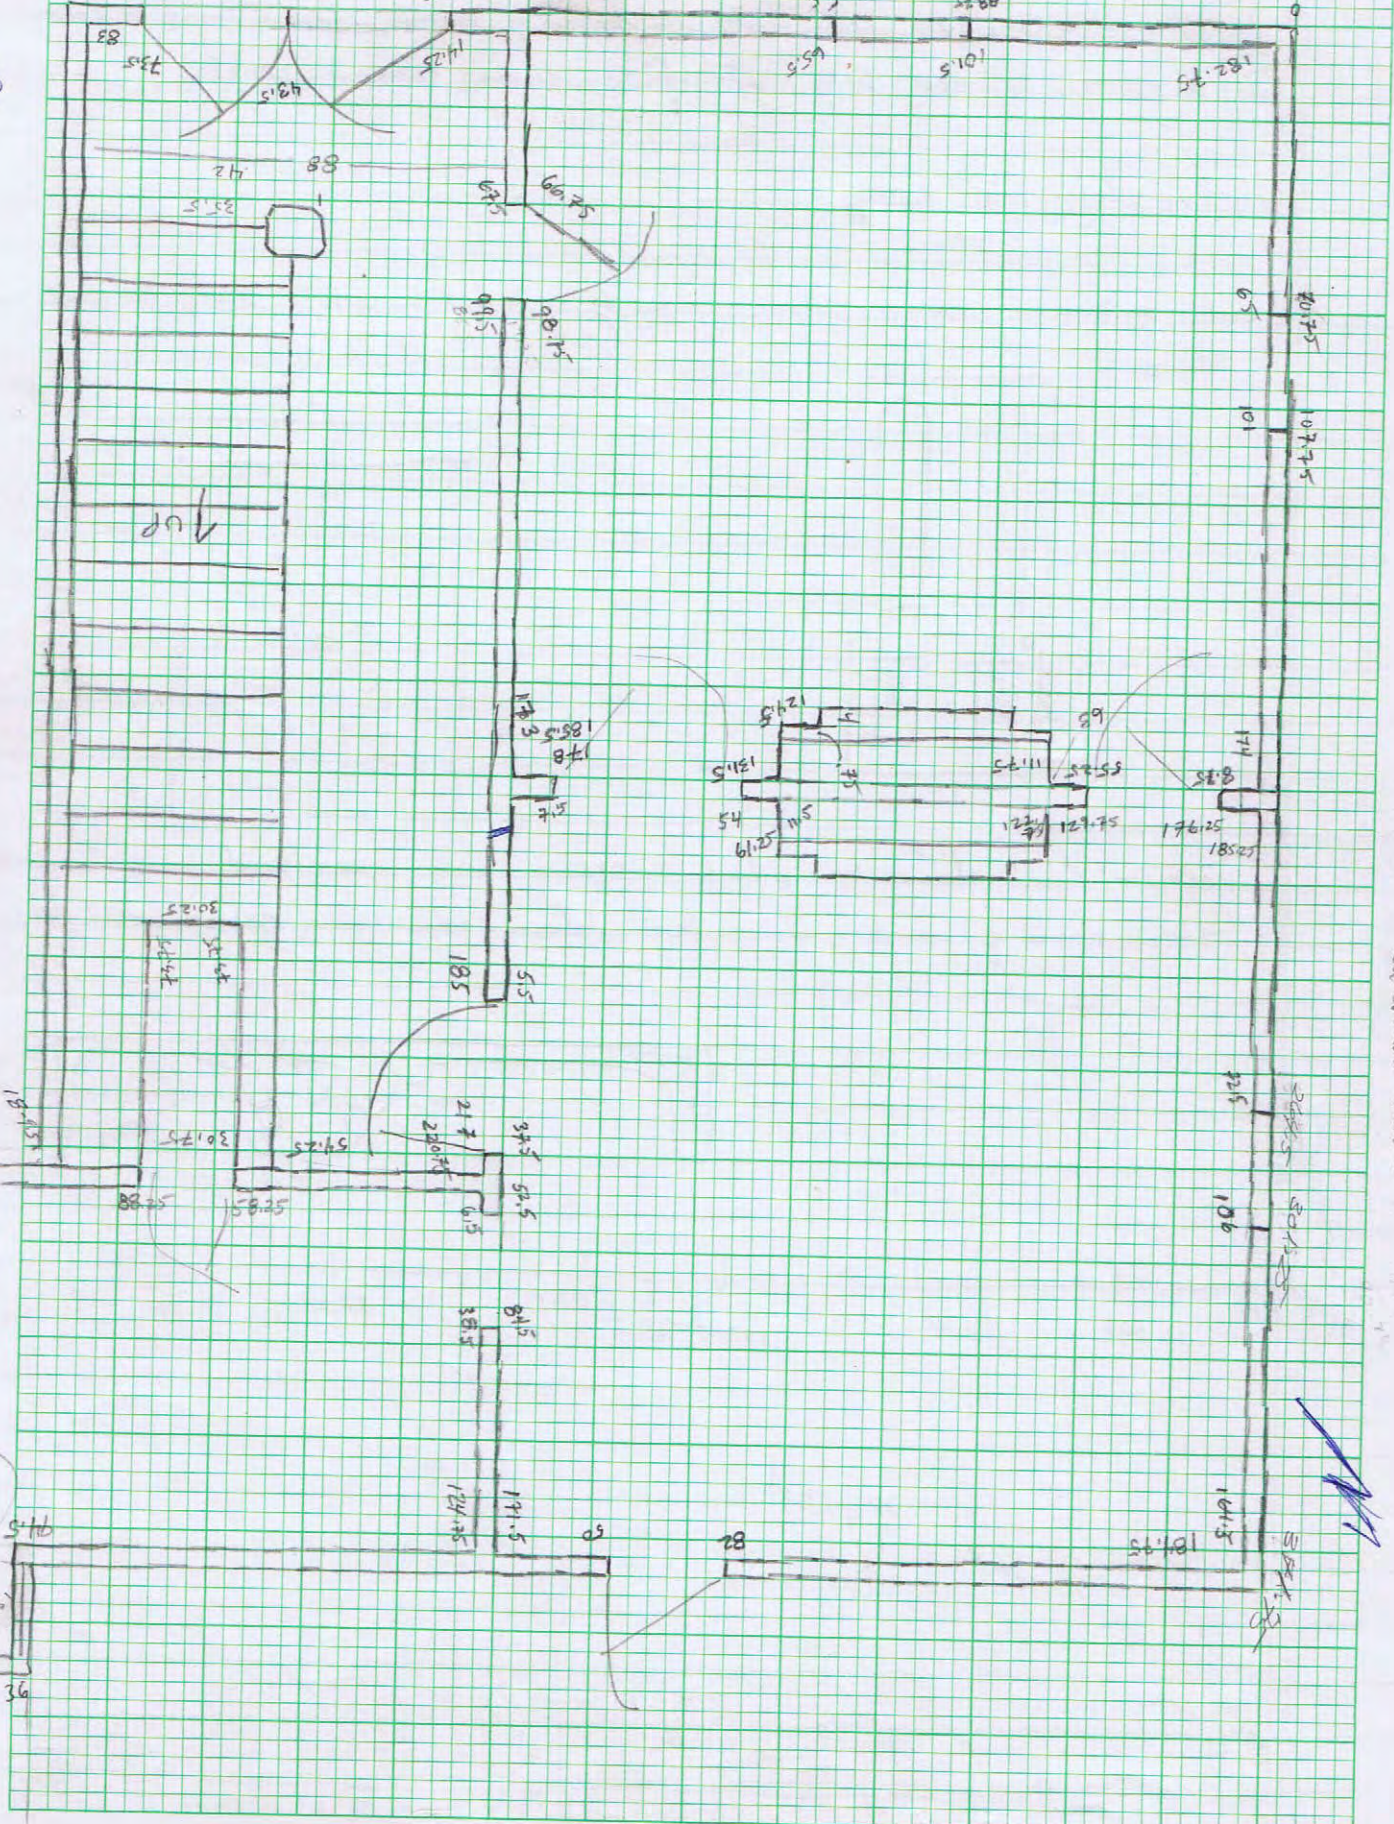
2nd Story BARN AND CARRIAGE HOUSE

CHESTNUT ST 1ST story

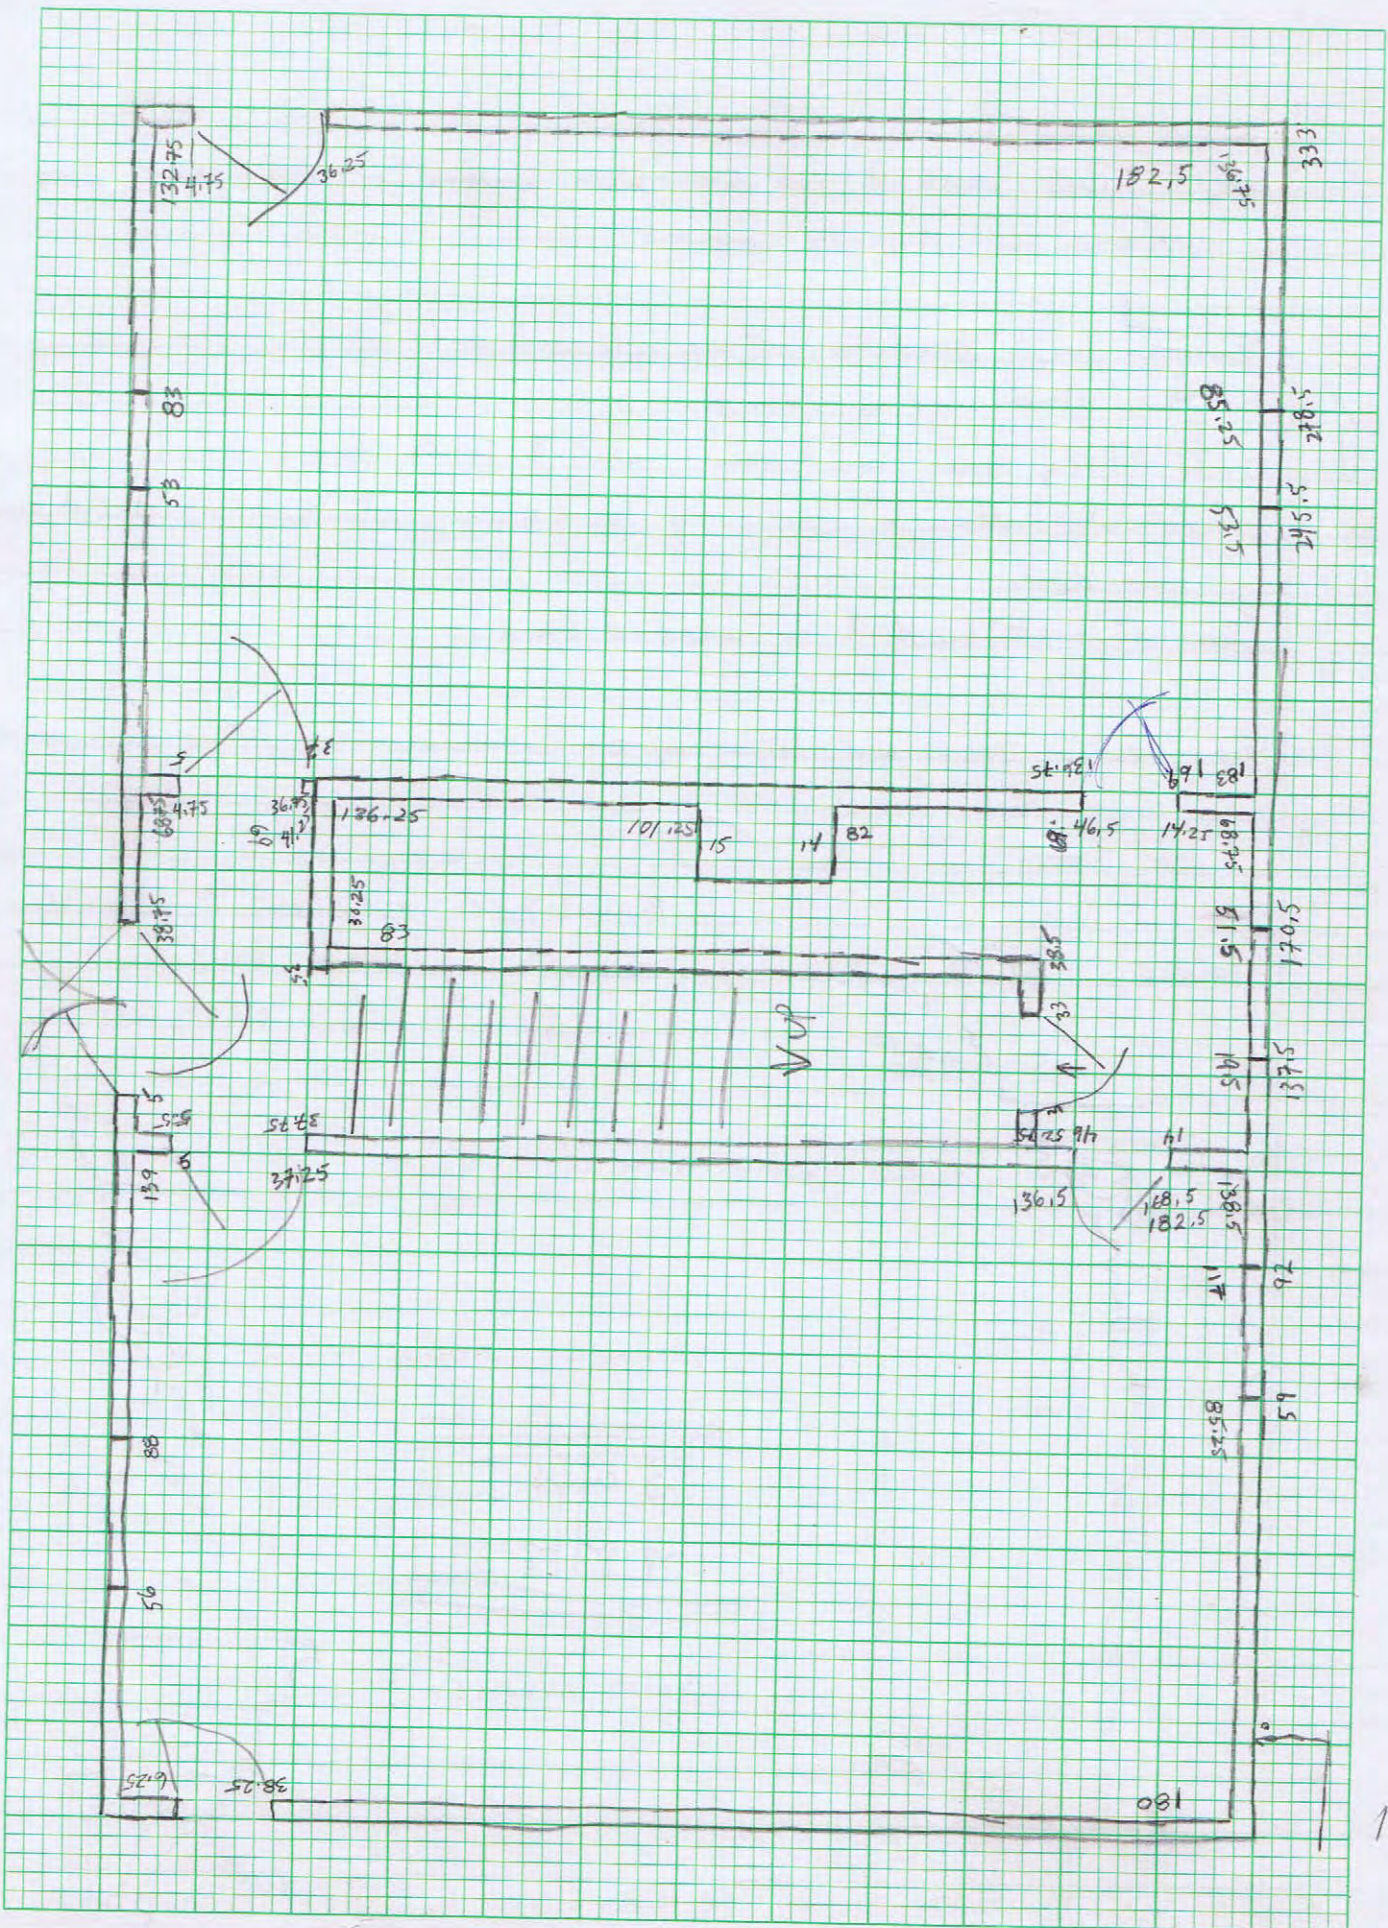
All corners have 1" chamfer
