Changes in an Old New Castle Row House

Julie K. Wellman

Vernacular Architecture

18 December 1989

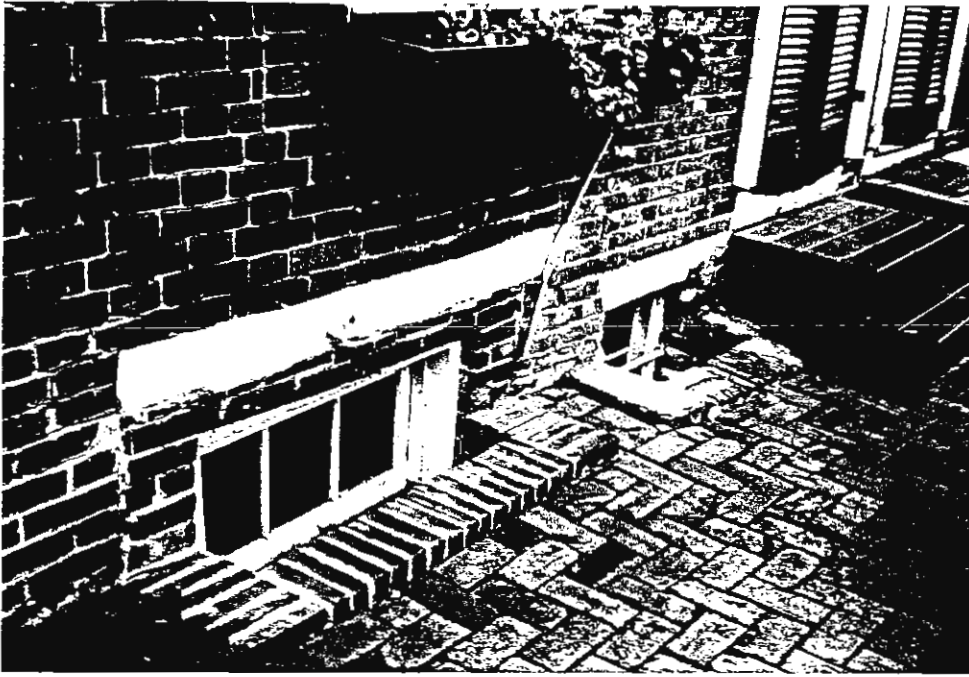
The basement was built with two doors- one inside leading into the first floor parlor and one entry from the street which provided easy access to the kitchen, originally located in the basement. A major traffic flow change occurred when the street entrance into the basement was bricked (Fig. 1 and Fig. 2).

The occupants may have bricked the exterior door when the kitchen was moved to the first floor. Only one house on Cloud's Row has retained the exterior entrance to the basement (Fig. 3). According to Charles Lockwood, author of Bricks and Brownstone, dining as well as cooking was often done in the basement. From travel accounts he found that few people in the social class that lived in this type row house ever held formal dinner parties so there was no need for a separate dining room (Lockwood). Also, the narrow staircase to the first floor prohibited carrying food to a first floor dining room. Dumb waiters were not an option at the time Cloud's Row was built because that feature did not arrive in the United

Fig. 2. Exterior of bricked entry to basement.
