**BANKS BUILDING
NEW CASTLE, DELAWARE**

**OCTOBER 10, 2011 INSPECTION
&
CONDITION REPORT**

**Prepared for the
Mayor and Council of New Castle, Delaware**

Richard O. Byrne
Architectural Conservator
Staunton, Virginia

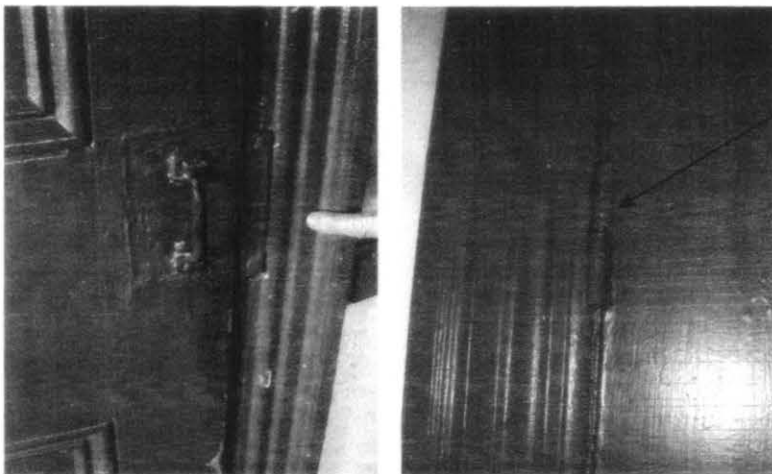
On the first floor we have an original entry door, and two interior doors...one with bolection moldings on both sides of its panels and one door with bolection moldings on only one side of its four panels. There appears to be an original chair rail in the south 1st floor room near its entrance door that bows out 2 inches from the width of the stair wall so as to give a slightly larger entryway at the side door.

There is sufficient door hardware present to detail a surface mounted 4"x 5" vertically mounted surface locks and keepers. One keeper is still present, as is an escutcheon for the door knob and shaft, and a cast iron escutcheon for the key hole. Also present on this interior entrance door is a pair of cast iron "lift-off" hinges and their original screws. When the screws are

removed during their cleaning one will probably find screws with a tapered pointed end and not blunt ends that were replaced in the 1840s. The doors themselves would easily be re-made.

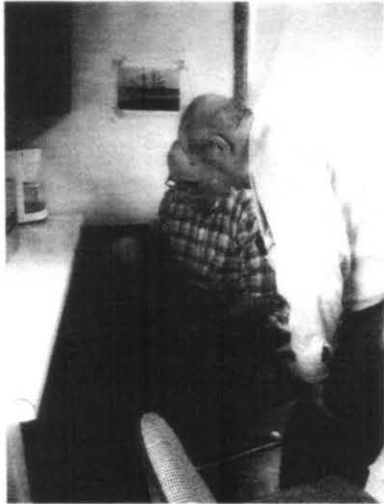
The original 1st floor floorboards on the interior seems to have been removed completely except under the staircase and a ¾" plywood floor installed with modern plastic tiles adhered to it. A large 1 x 2 foot hole has been cut through it by someone investigating the interior condition of the joist system and the foundation that has been covered over on the outside. The soils under this opening are powdery dry, there appears little efflorescent of salts on the side of the exposed inner foundation brick wall which indicates little if any rising damp, and a soil under the building (and probably around the building since it was built) that drains water away rather rapidly,

Numerous ½"holes were drilled around the interior perimeter on the 1st floor and a fiber optic scope inserted so that other areas of the foundation walls and the condition of the joist could be observed. Little if any rising damp was observed and little if any fungal outbreak is present.
